Structural Assessment Report:
Key West Historic Diesel Plant

Property Address:
**100 Angela St & 709 Fort St & 101 Geraldine St
Key West, FL 33040**

Serge Mashtakov, PE, FL License No. 71480

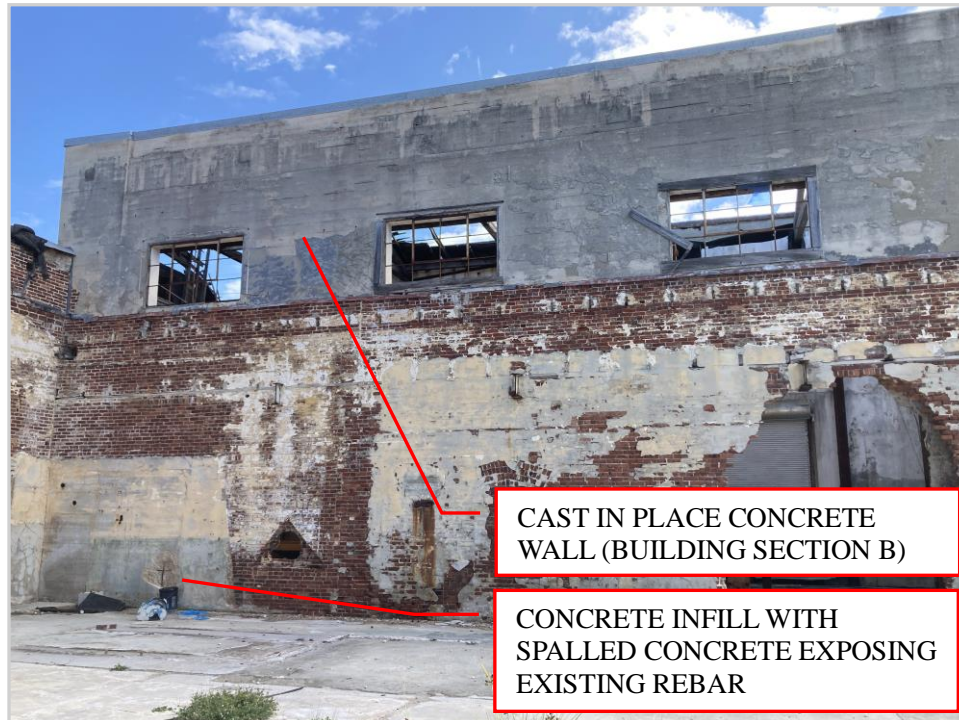
The upper half of Building Section B and some infilled wall openings are constructed of cast in place concrete, with minimal steel reinforcement bar. This wall did not evidence significant damage; however there are two locations in need of patch repairs.

It is recommended that the existing concrete wall be repaired, with partial section patch repairs.

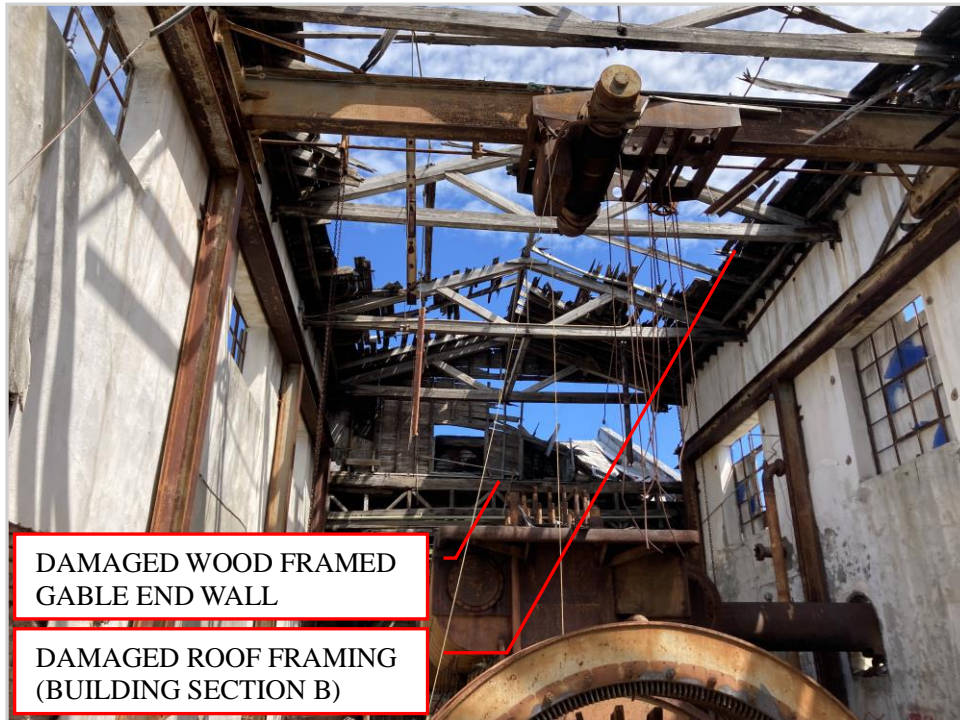
Building Section B: The existing wood frame roof is significantly damaged throughout this section. This roof framing bears on the two exterior walls (cast in place concrete). The framing consists of timber girder trusses spaced at approximately 12' on center, with secondary wood framing between the girder trusses.

It is recommended that the roof framing in section B be reconstructed in its entirety. New framing should match the timber girder truss aesthetic.

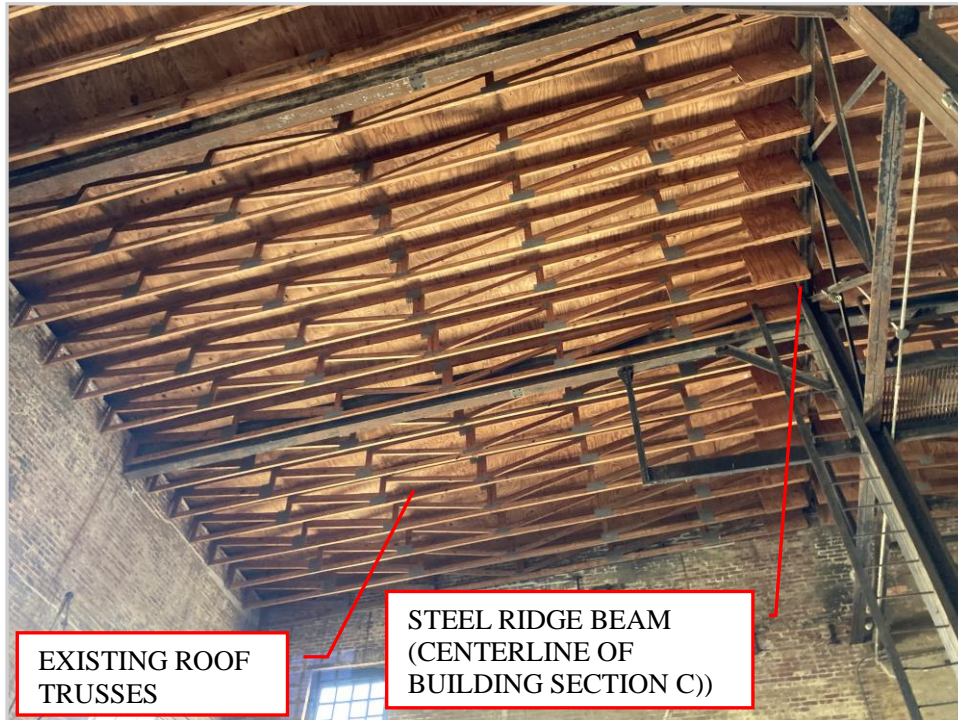
Building Section C: The existing wood roof trusses in this area did not evidence significant damage or deterioration. The roof in this section was originally constructed of concrete, supported by exterior walls and interior steel framing. Per 2001 plans provided by KEYS Energy Services, this concrete roof was removed and replaced with the trusses that exist today. It should be noted that the trusses lack any bottom chord bracing; this bracing is critical to resist large wind uplift loads.

It is recommended that this roof framing remain with the following voluntary improvements:

1. Provide bottom chord bracing by wood frame bracing or continuous sheathing (or furring & drywall)
2. Retrofit existing roof-to-wall anchors to meet current wind loads. One anchor strap currently exists; however, an additional strap may be necessary to meet current Florida Building Code loads.

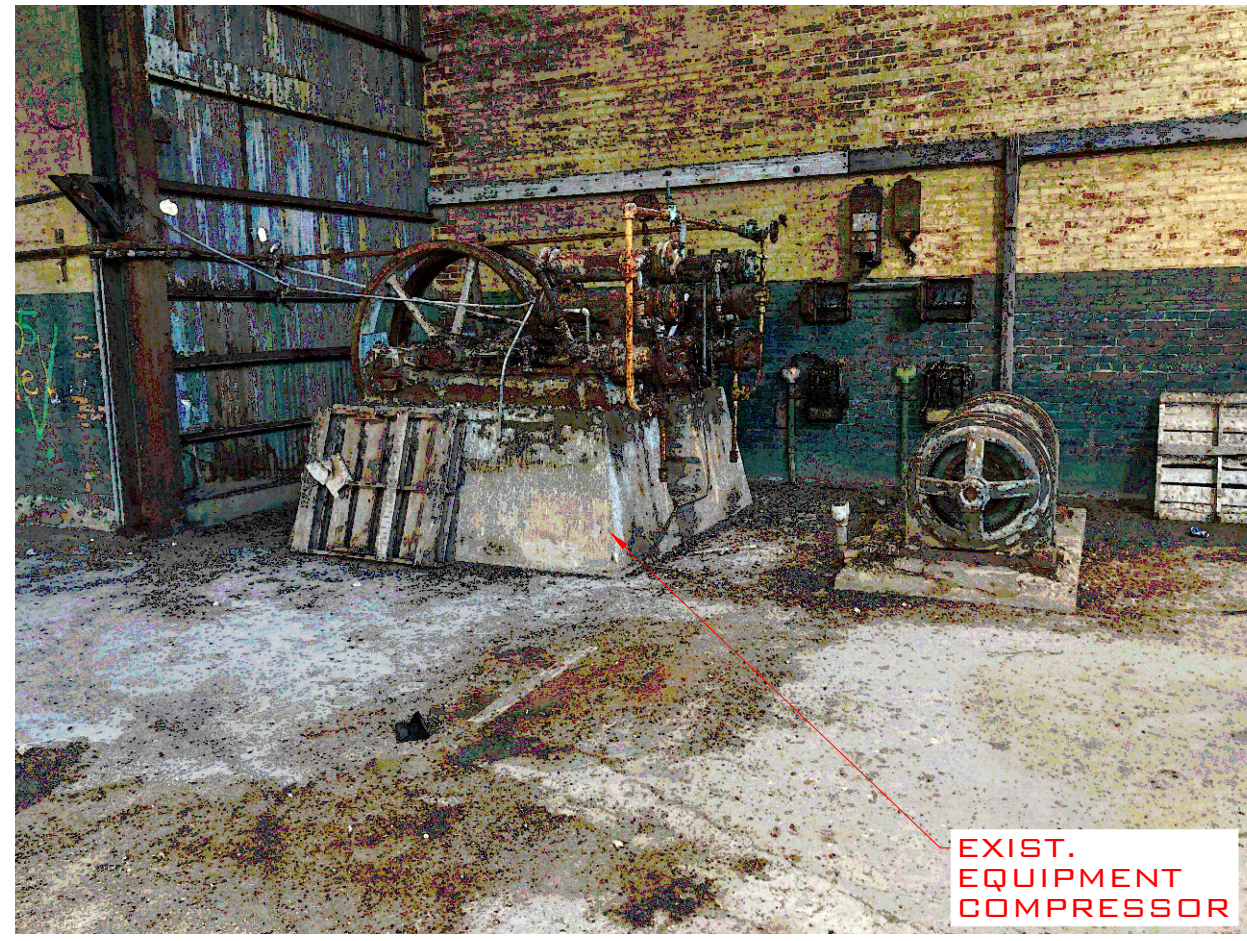
PHOTO F01

EXIST. EQUIPMENT COMPRESSOR

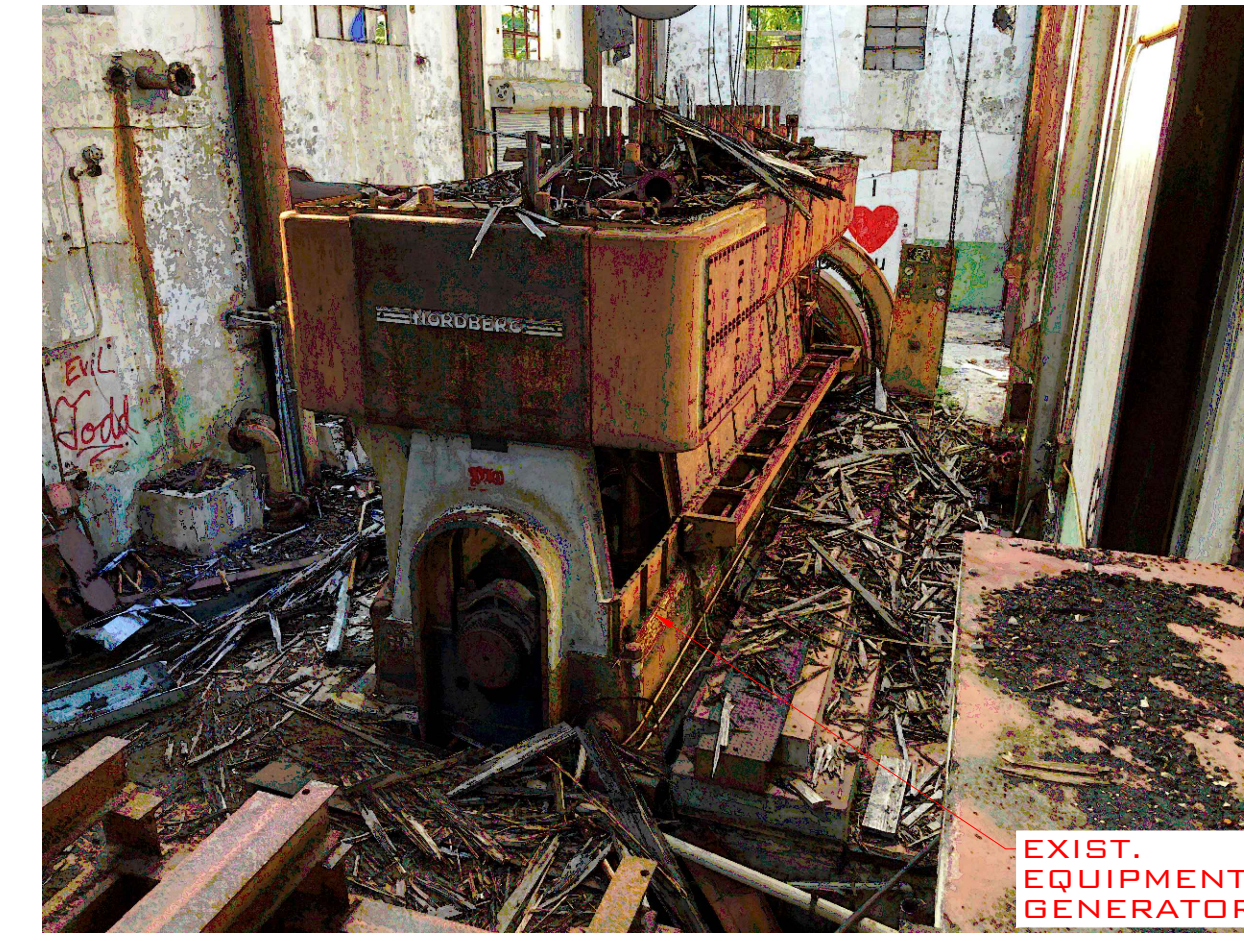
PHOTO F05

EXIST. EQUIPMENT GENERATOR

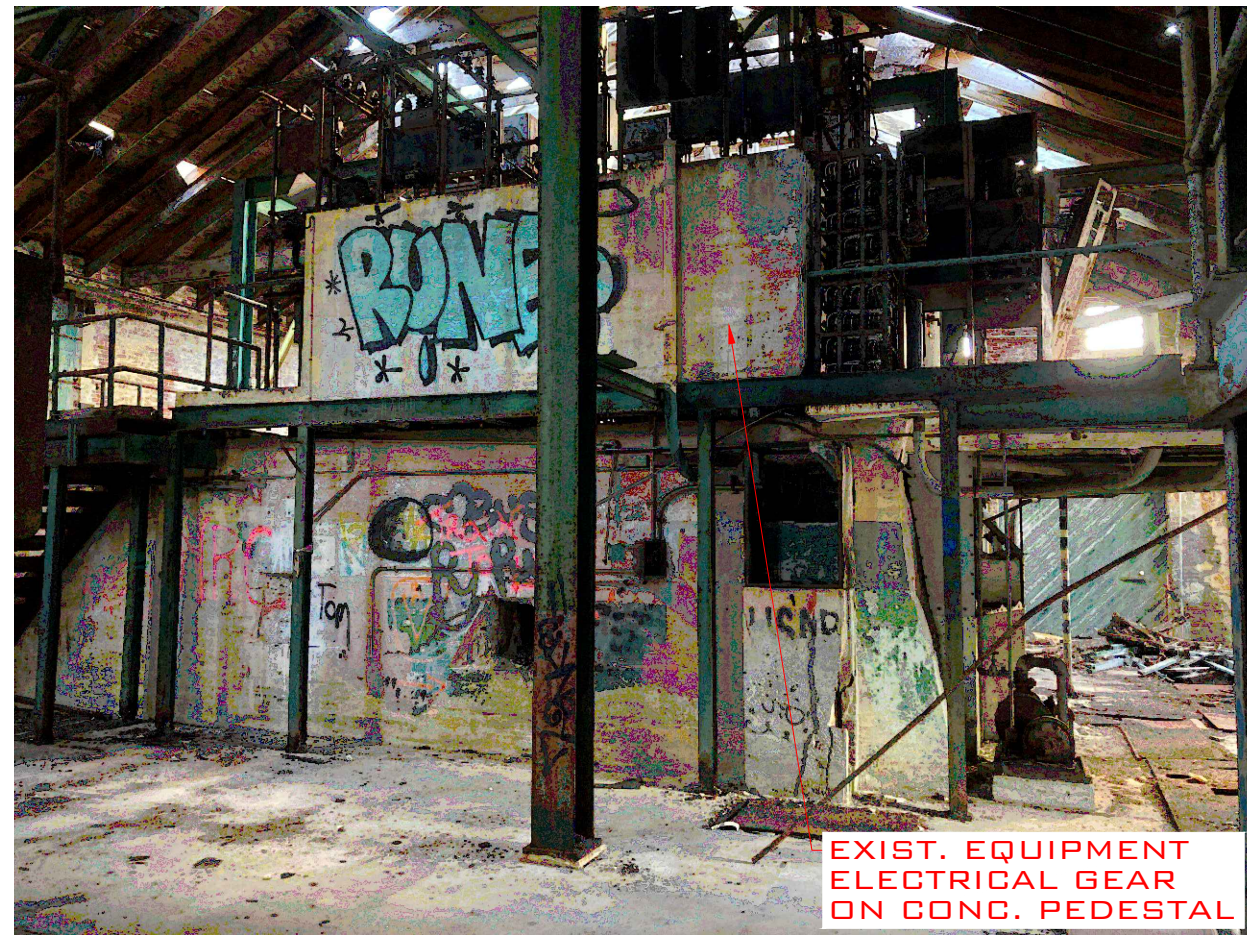
PHOTO F06

EXIST. EQUIPMENT ELECTRICAL GEAR ON CONC. PEDESTAL

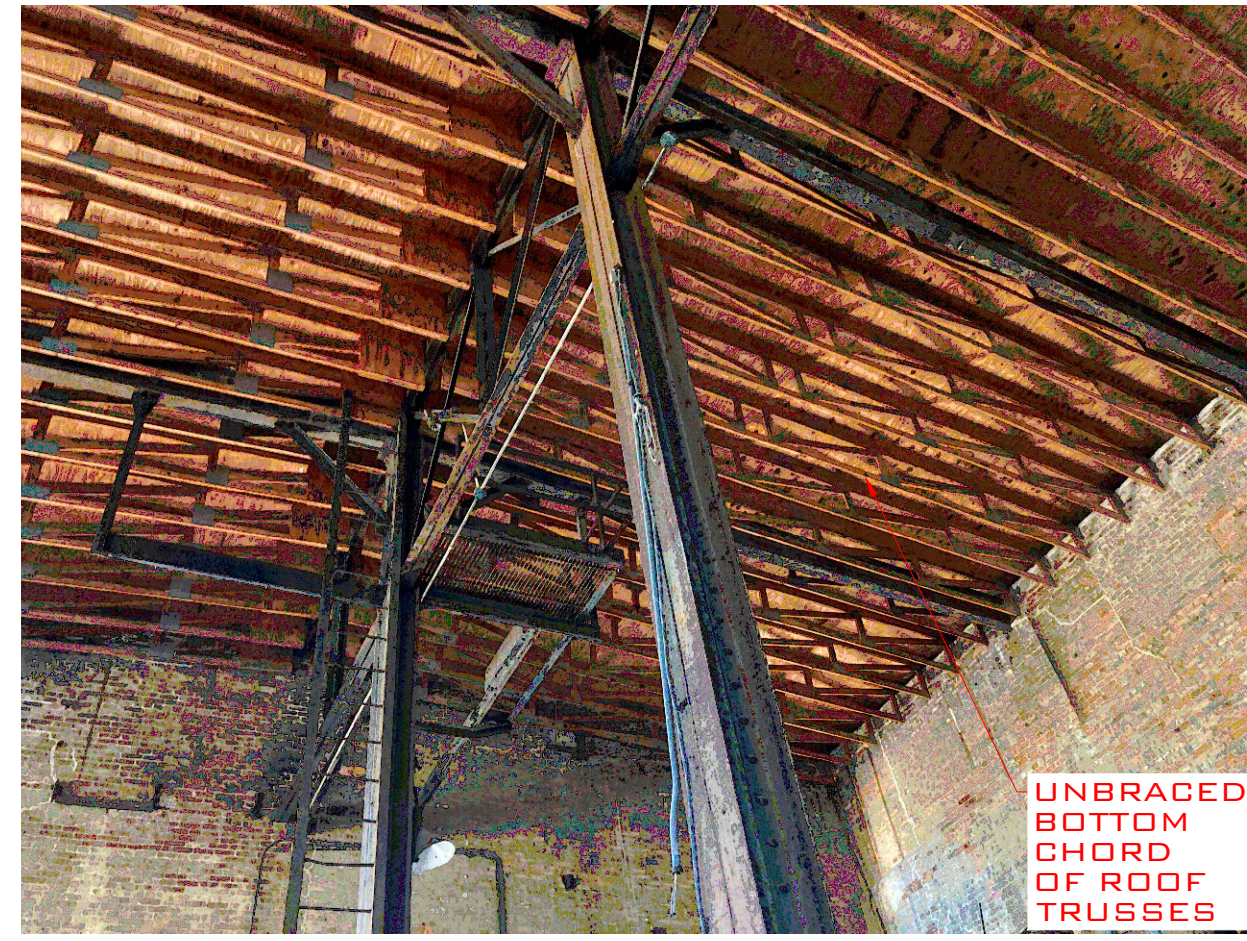
PHOTO R02

UNBRACED BOTTOM CHORD OF ROOF TRUSSES

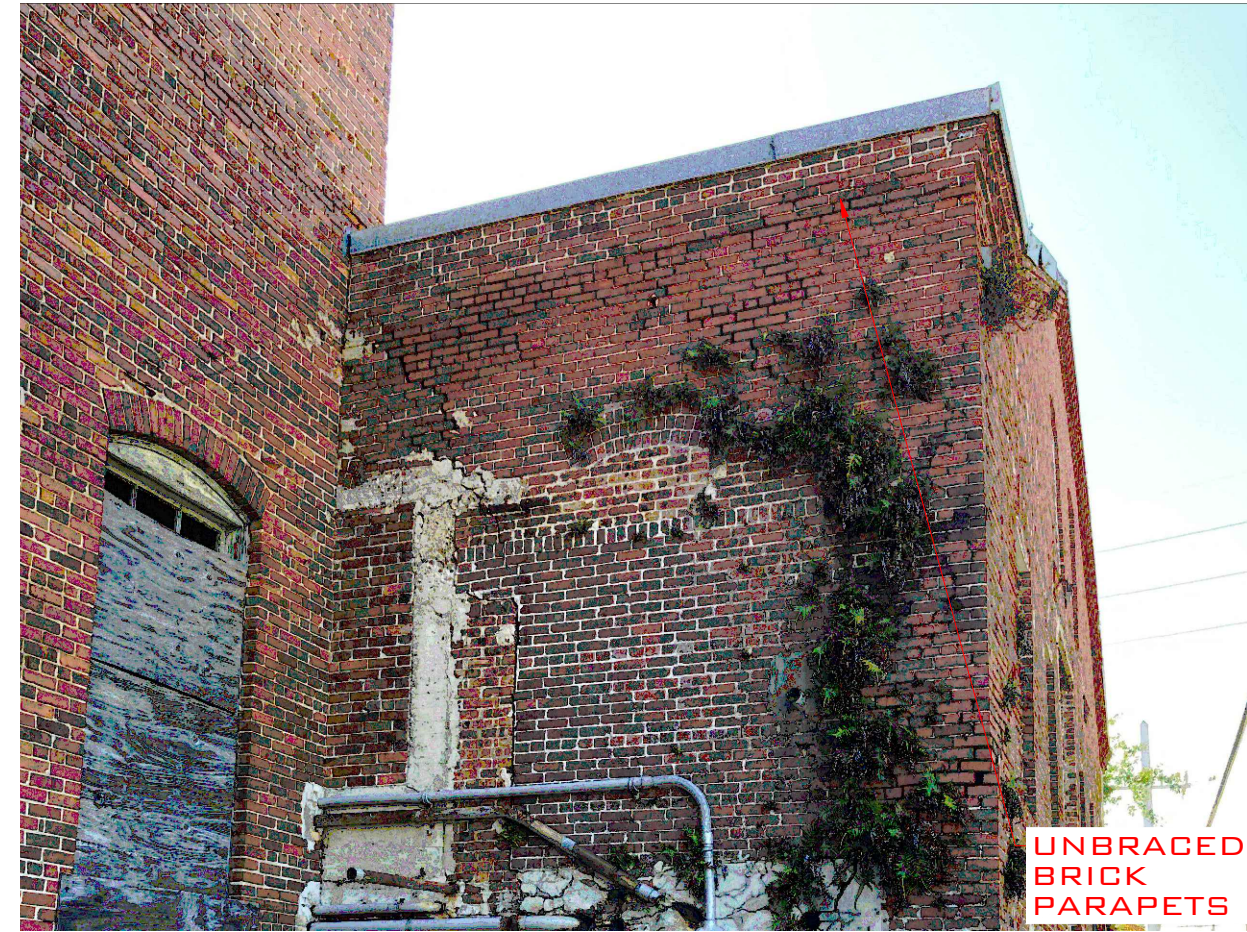
PHOTO R07

Building Section A contains parapets that are constructed of unreinforced brick. These parapets may be susceptible to failure during high wind loads.

UNBRACED BRICK PARAPETS

It is recommended that the wind loads on these parapets be analyzed during design, to determine if bracing is required. Bracing can anchor parapets to the roof diaphragm or adjacent walls. Additionally, the design of the roof crickets may be detailed to brace the parapets.
