CITY OF KEY WEST

PROJECT: GR1503 / SEAWALL REPAIR & REPLACEMENT OPTIONS

SEPTEMBER 2015

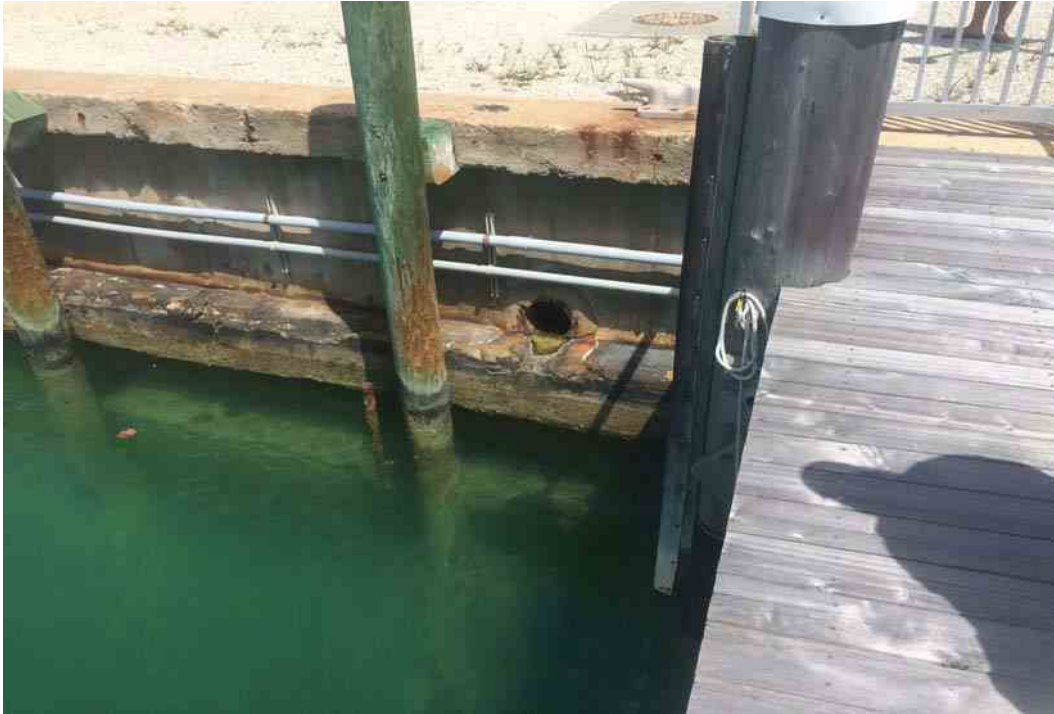
3) Typical View of Existing Seawall with Drain Crossing

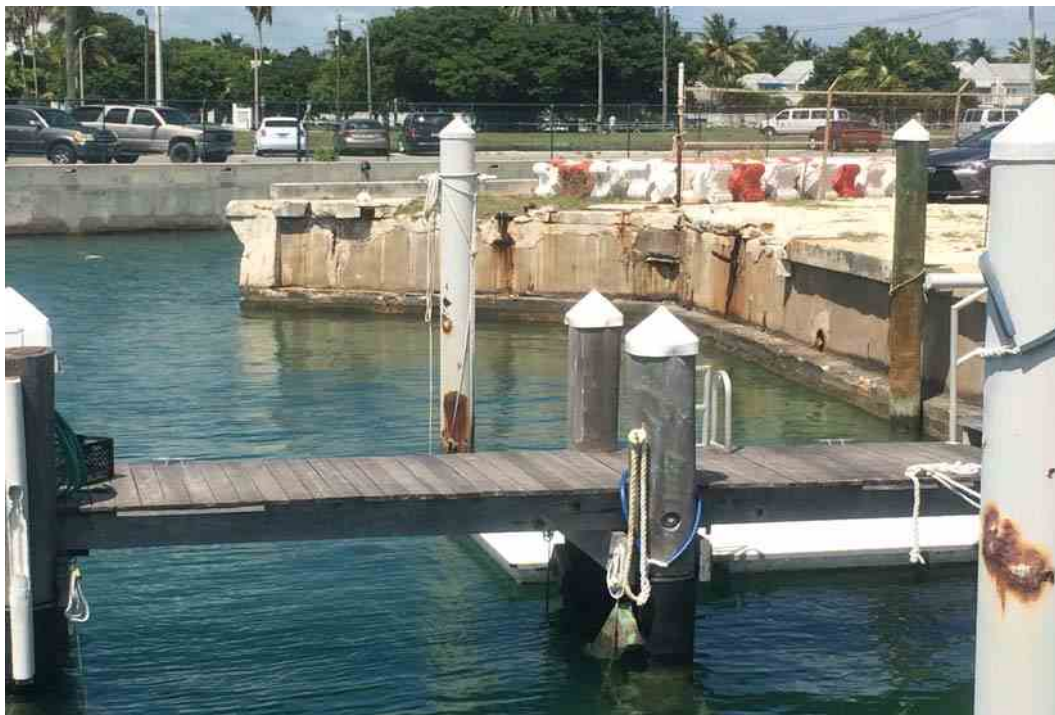
6) East End of Seawall

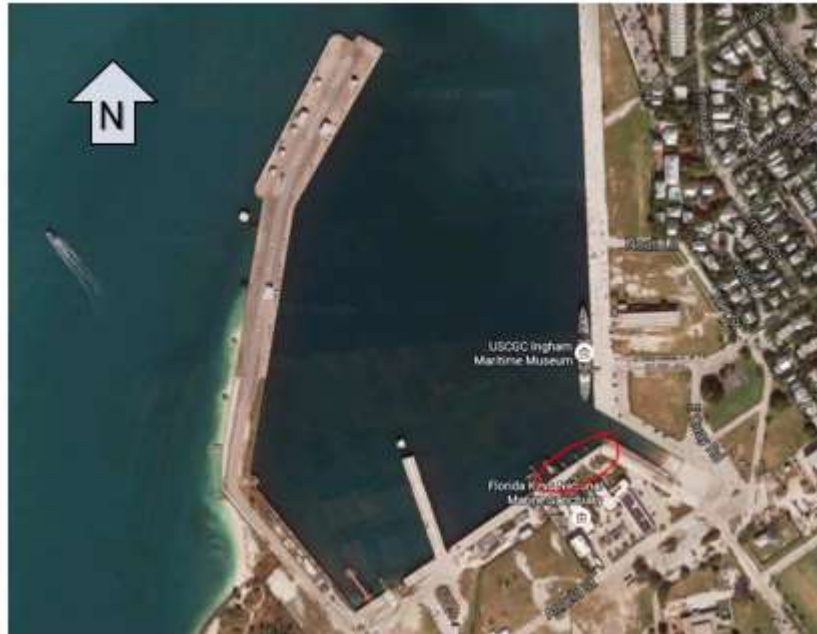
Photo: 1

Next to the Northeast end of the seawall, this is the adjacent seawall, leading toward the boat ramp. Looking Southeast.

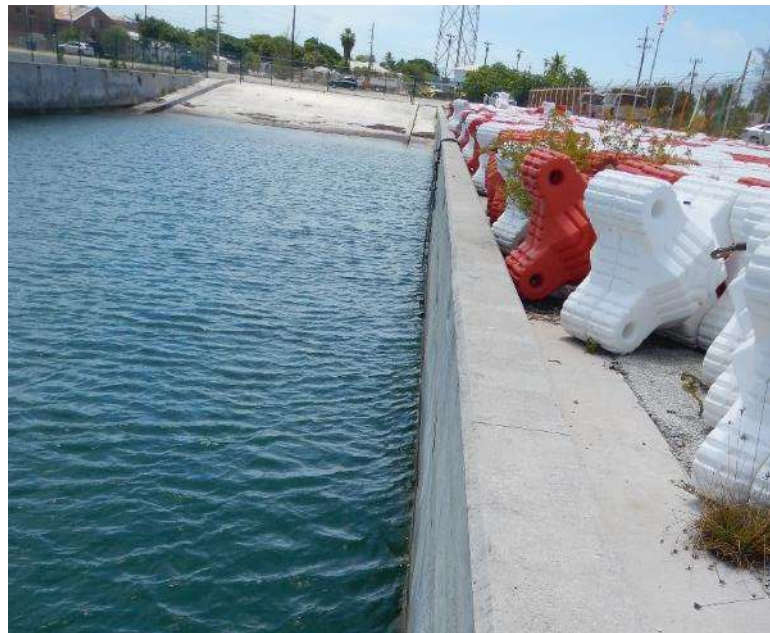
Next to the Northeast end of the wall, this is the adjacent seawall which forms the triangle toward the end of the NOAA seawall. This side of the seawall is made with concrete capped steel sheet piles. Looking Northwest.

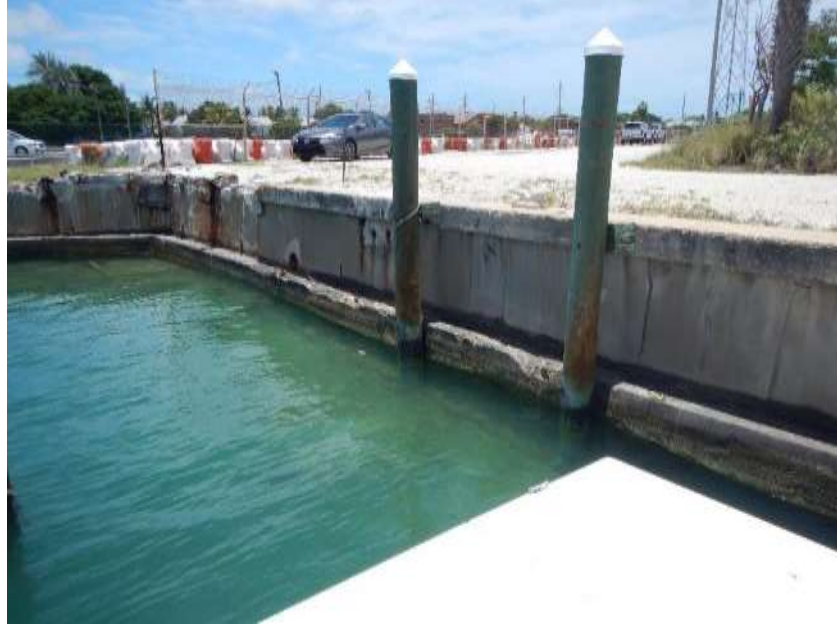
Photo: 7

View of the seawall from
Dock 1 – right.

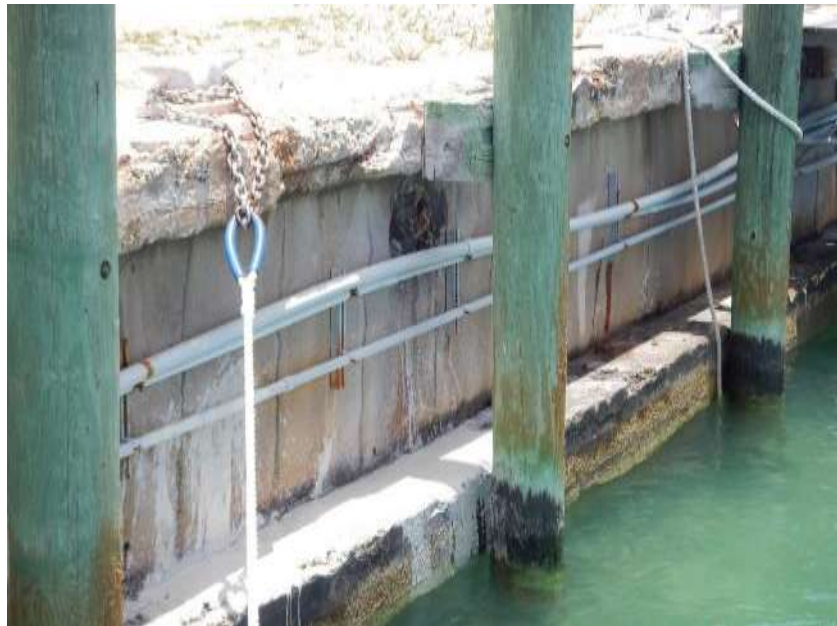
The second dock along the NOAA seawall, Dock 2.

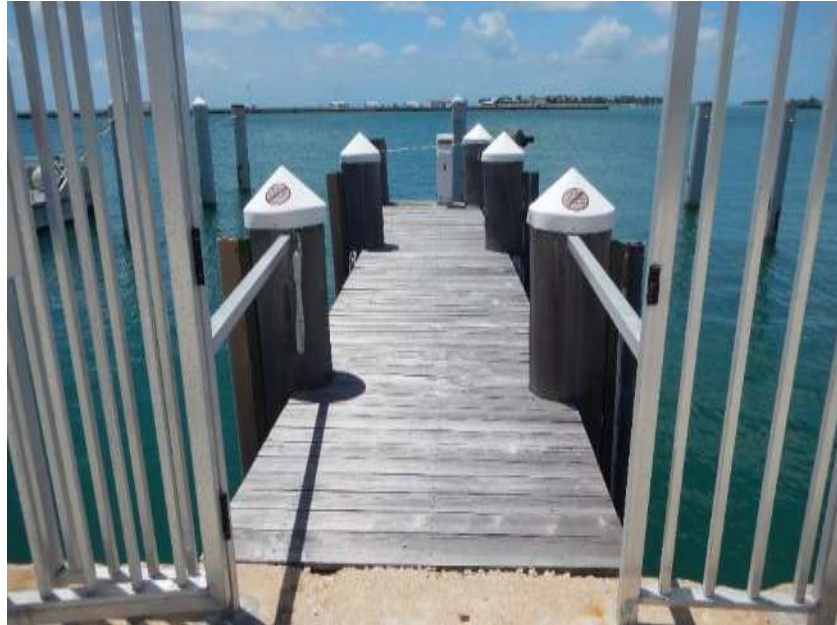
Photo: 10

Description:
The third dock along the NOAA seawall, Dock 3.

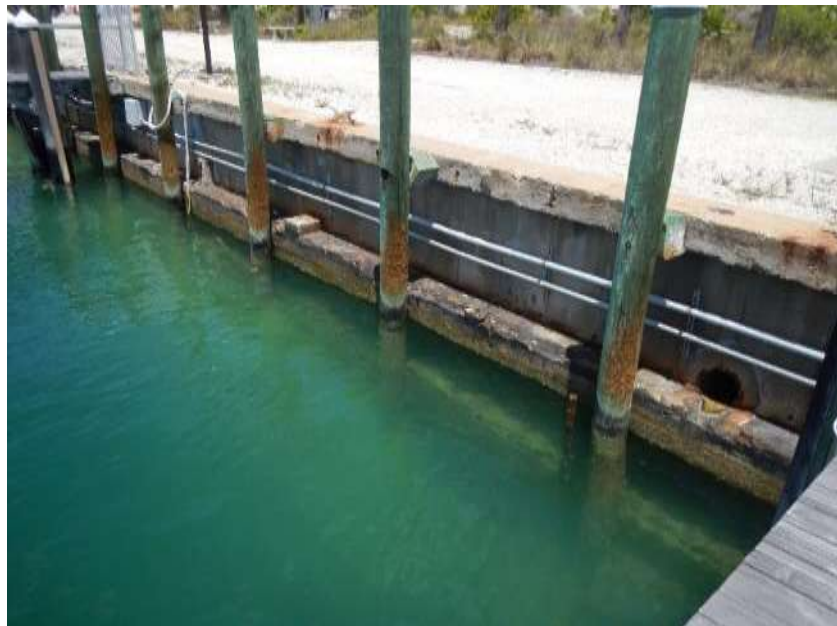
Photo: 11

Description:
View of the seawall from Dock 3 – left. The quikrete bags appear to stop between Docks 2 and 3, and a concrete wall takes its place, running from the edge of the seawall to the top of grade.

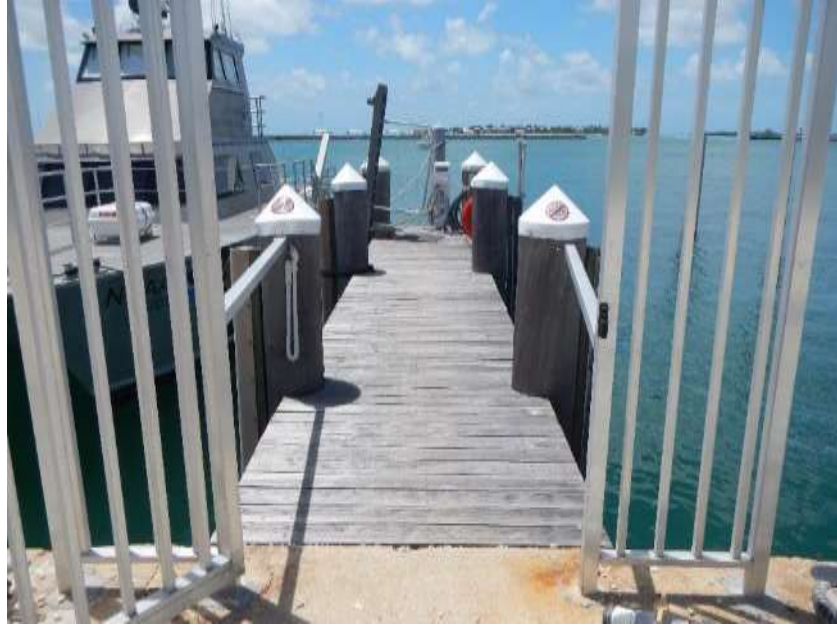
Photo: 12

Description:
The fourth dock along the NOAA seawall, Dock 4.

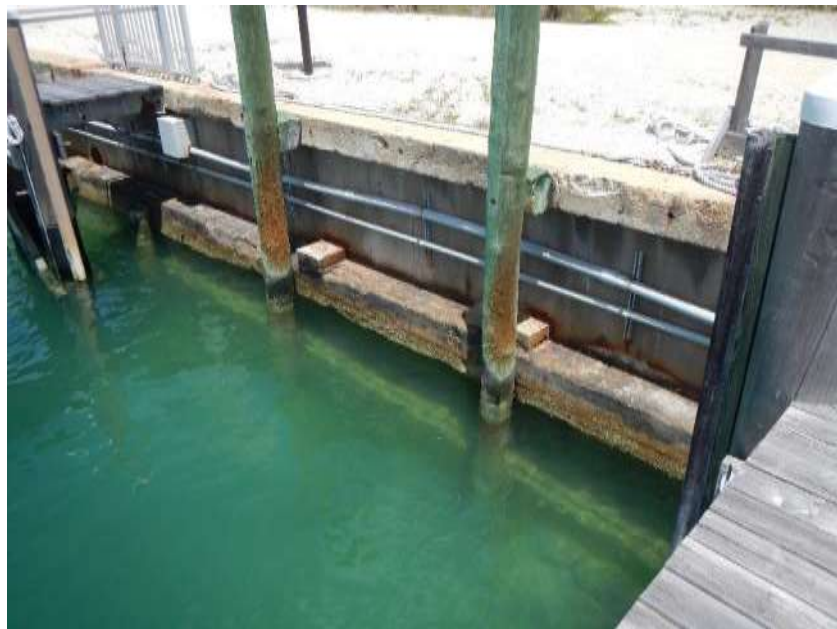
Photo: 13

Description:
View of the seawall from Dock 4 – left. The concrete wall along the bottom appear to continue through the end of the seawall.

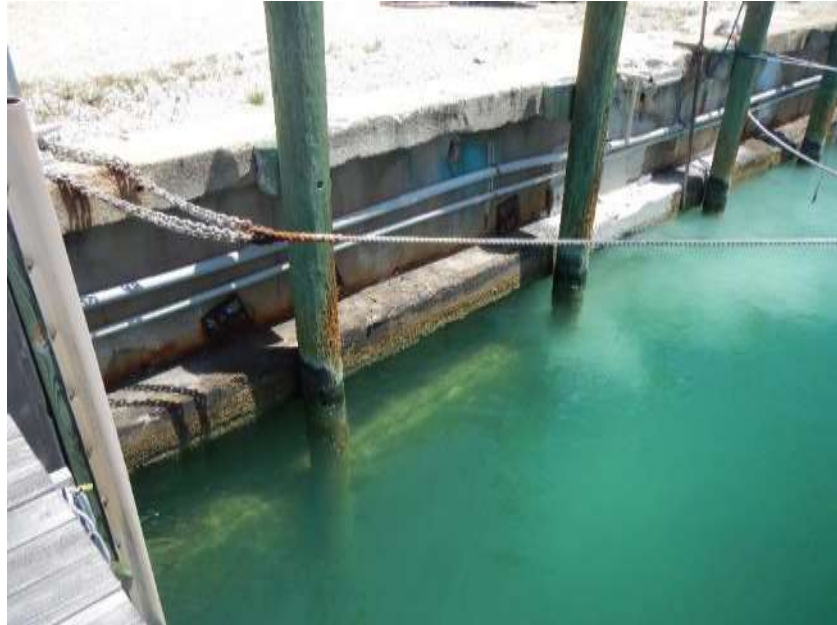
Photo: 14

Description:
View of the seawall from
Dock 4 – right.

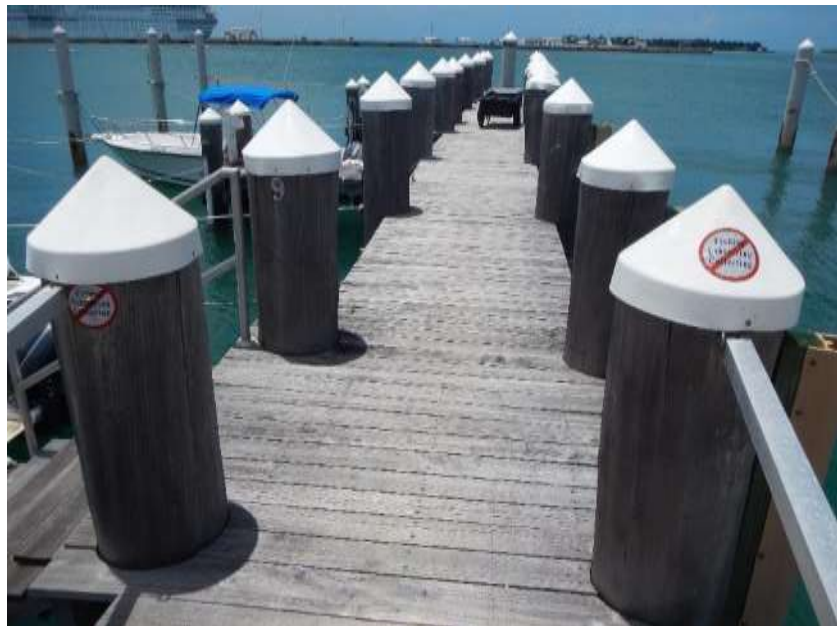
Photo: 15

Description:
The fifth and last dock
along the NOAA seawall,
Dock 5. This dock goes out
about 82 feet, and has 3
sets of steps leading to
slips along the left of the
dock.

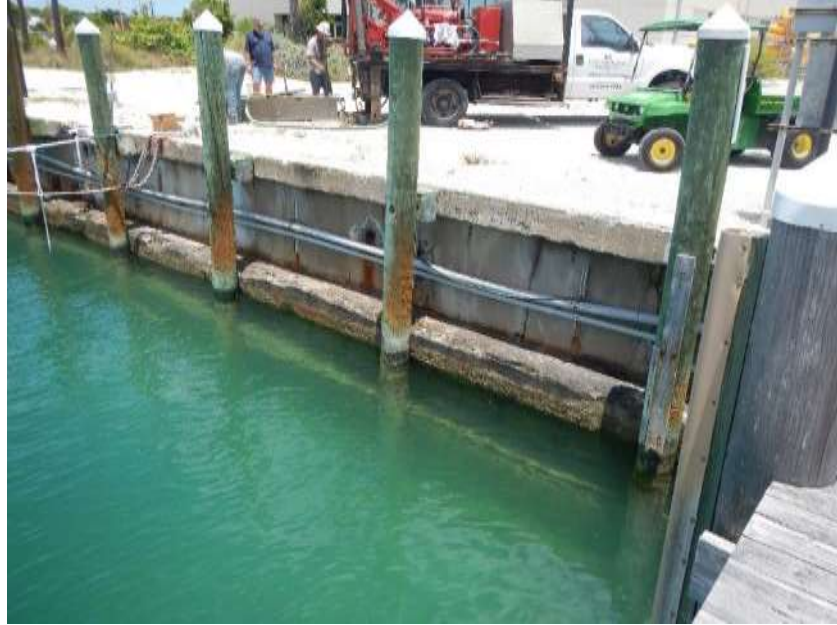
View of the seawall from Dock 5 – left. The location of the second soil boring can also be seen here.

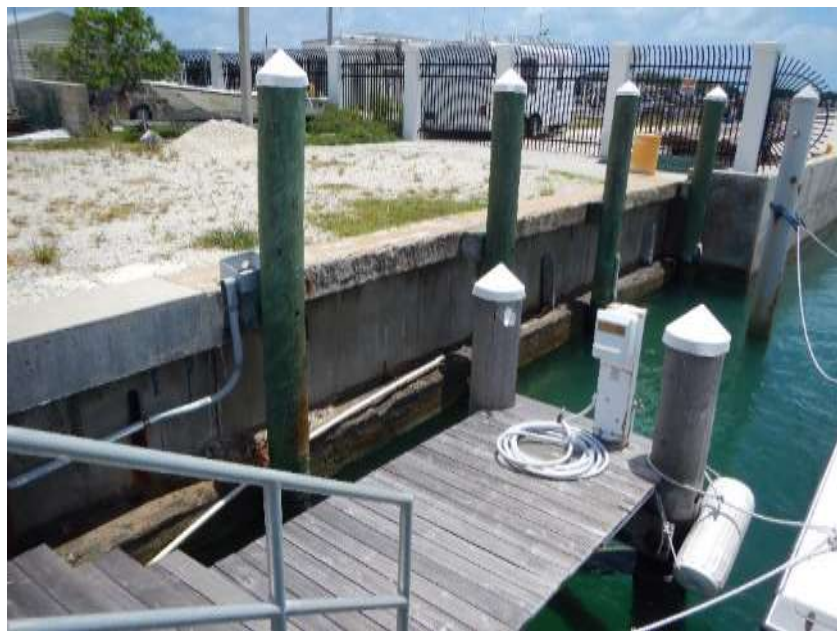
Photo: 17

View of the seawall from Dock 5 – right. The NOAA seawall ends, leading to the Navy seawall next door, on the Southwest end of the seawall.

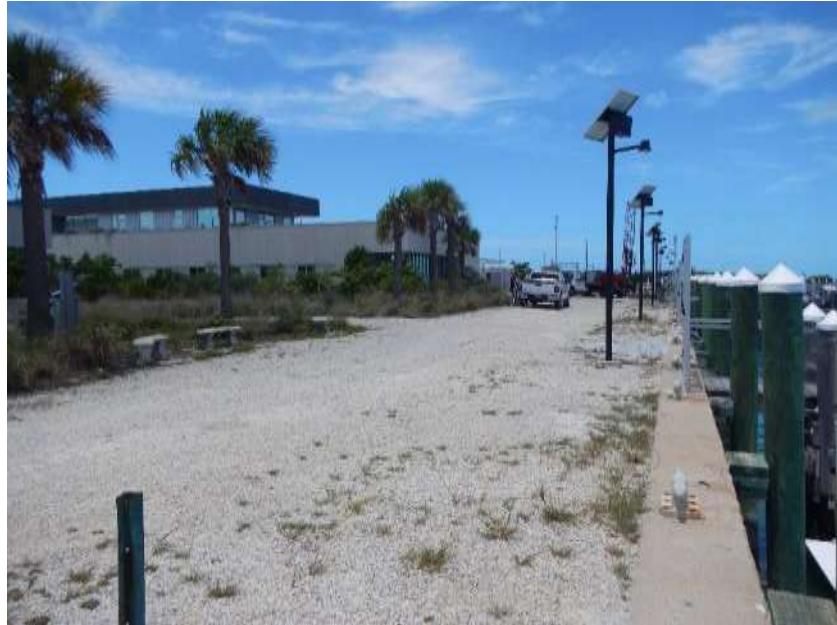
General view of the gravel path behind the seawall. The path is about 25 feet wide, with light posts by the entrance gate of each dock. Looking West.

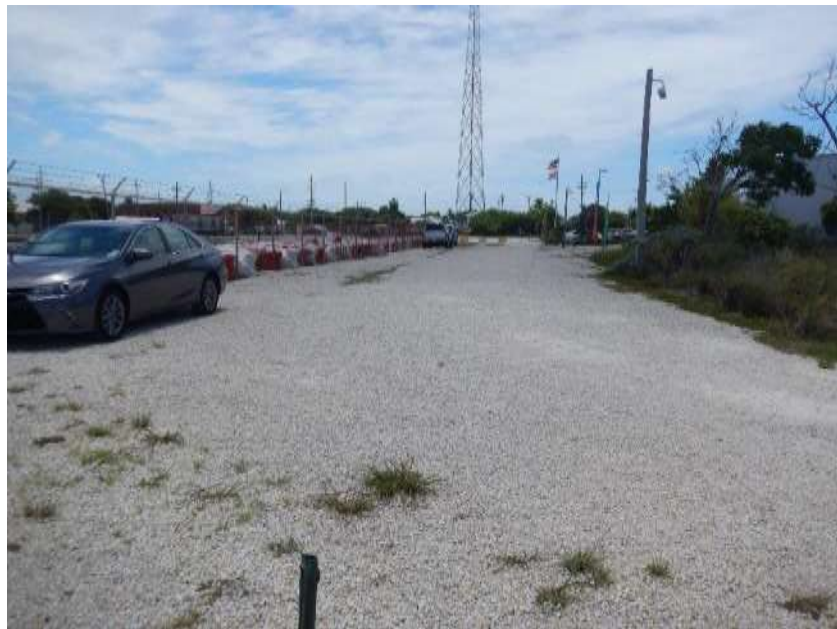
Photo: 19

General view of the gravel path leading toward the docks. Looking South.

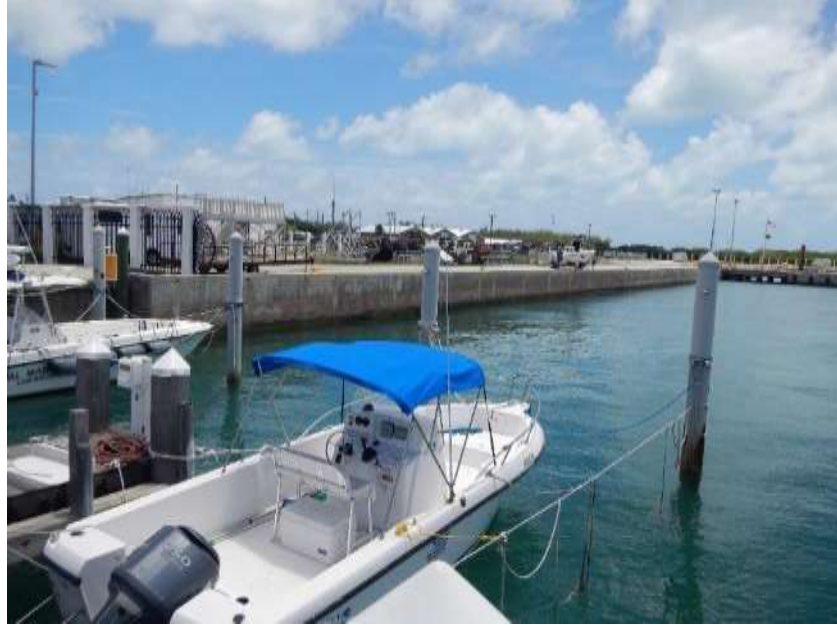
View of the neighboring Navy property on the Southwest end of the NOAA seawall.

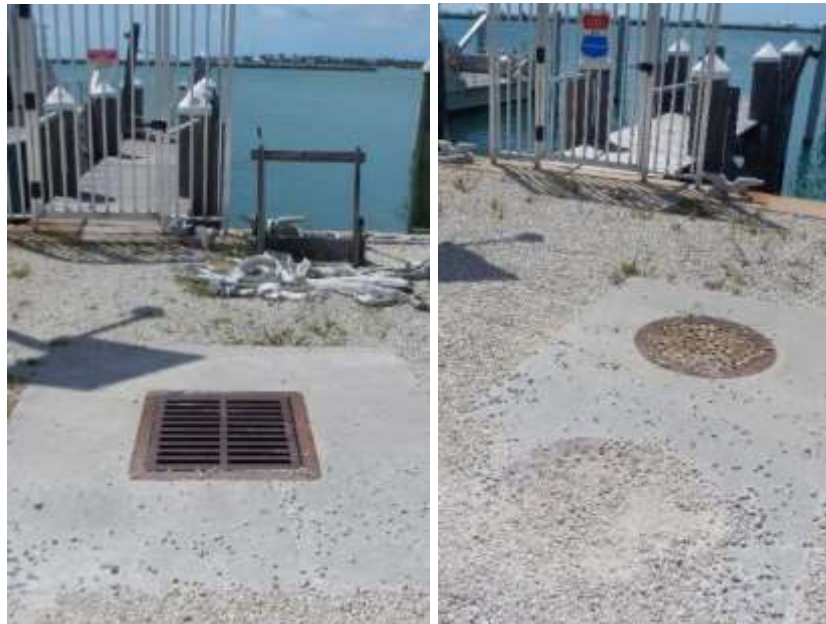
Photo: 21

At least two concrete pads were spotted on site, outside of the gates for Docks 3 and 4, with a storm water drain and utility manholes.
