**Subject: Seawall Condition Assessment
From Turtle Kraals to William Street
Resolution No. 17-017**

CITY OF KEY WEST
PORT & MARINE SERVICES

SEAWALL CONDITION ASSESSMENT
WATERFRONT MARKET TO TURTLE KRAALS RESTAURANT

RESOLUTION NO. 17-017

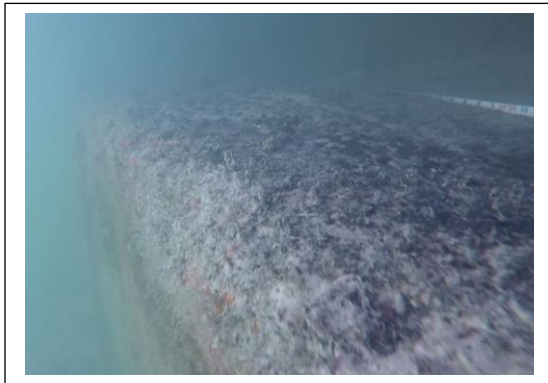
Figure 6: Station 0+55, looking east at existing toe

Condition: The bulkhead located in front of the Waterfront Market & Brewery appears to be in stable condition. The 1995 upland redevelopment plans show a gravity wall with a key wall located below the toe, but no dimensions or specifications were shown. Figure 6 shows the wall above the waterline. Figure 7 shows a previously installed toe wall at the mudline.

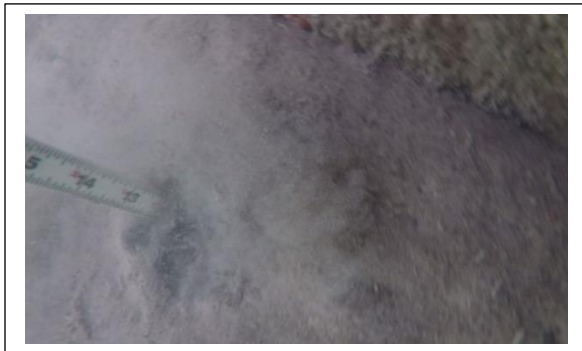
Figure 9: Sediment depths vary, here shown 12in

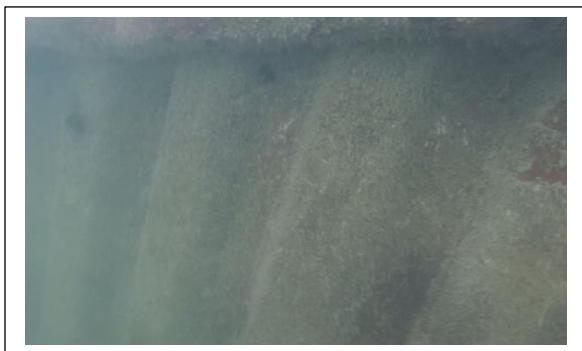
Figure 10: Station 1+10, Post construction toe wall

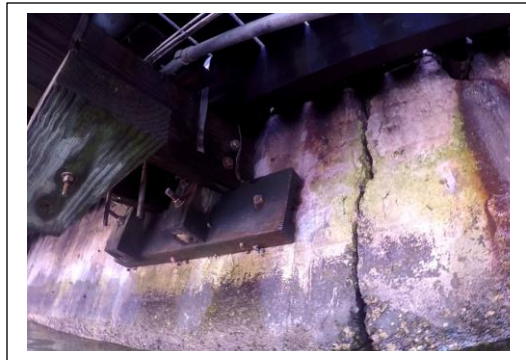
Figure 15: Station 3+18, looking east

Condition: The bulkhead located in front of the Waterfront Market & Brewery appears to be in stable condition. The above water line photo (Figure 15) shows a large crack that extends from the mudline to the top of the wall. This crack does not appear to be a construction joint and judging from the condition of concrete in the spalled areas, appears to have been there for a long time. We recommend that this portion of the wall continue to be monitored and re-inspected in three years. We also recommend that this large crack and several others along the face of the wall be sealed during the next phase of construction.

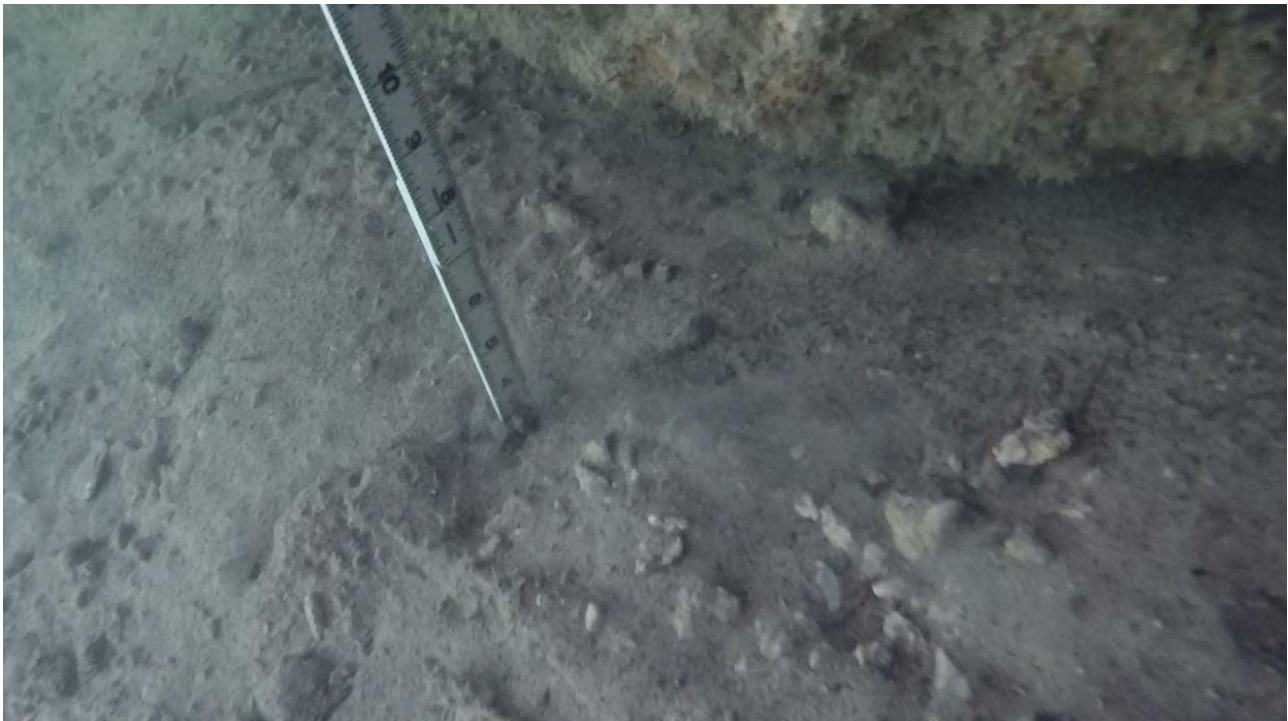
Underwater 2 - at 4ft 0in w continuous undermining at the toe and 4in sediment on top of rock

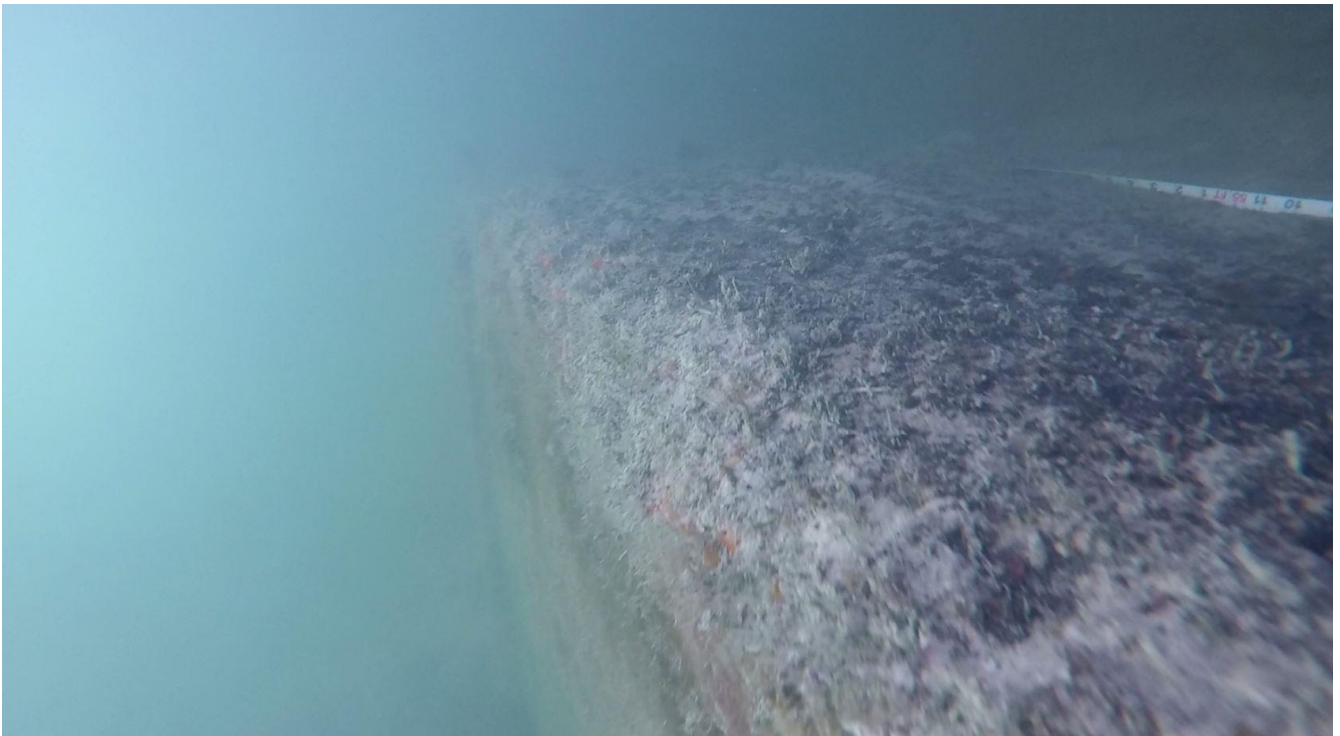
Underwater 11 - at 55ft shows concrete toe wall

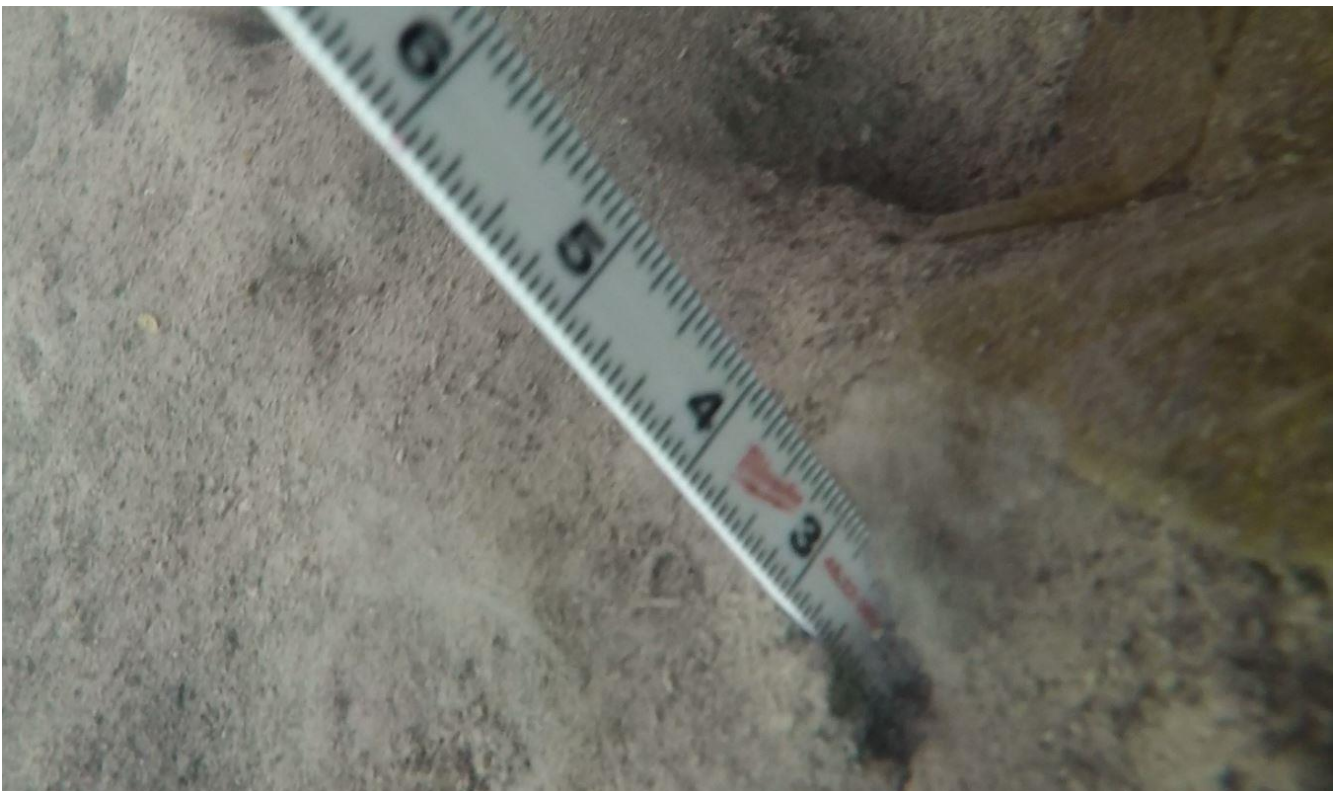
Underwater 12 - at 69ft shows sediment thickness at approximately 3in

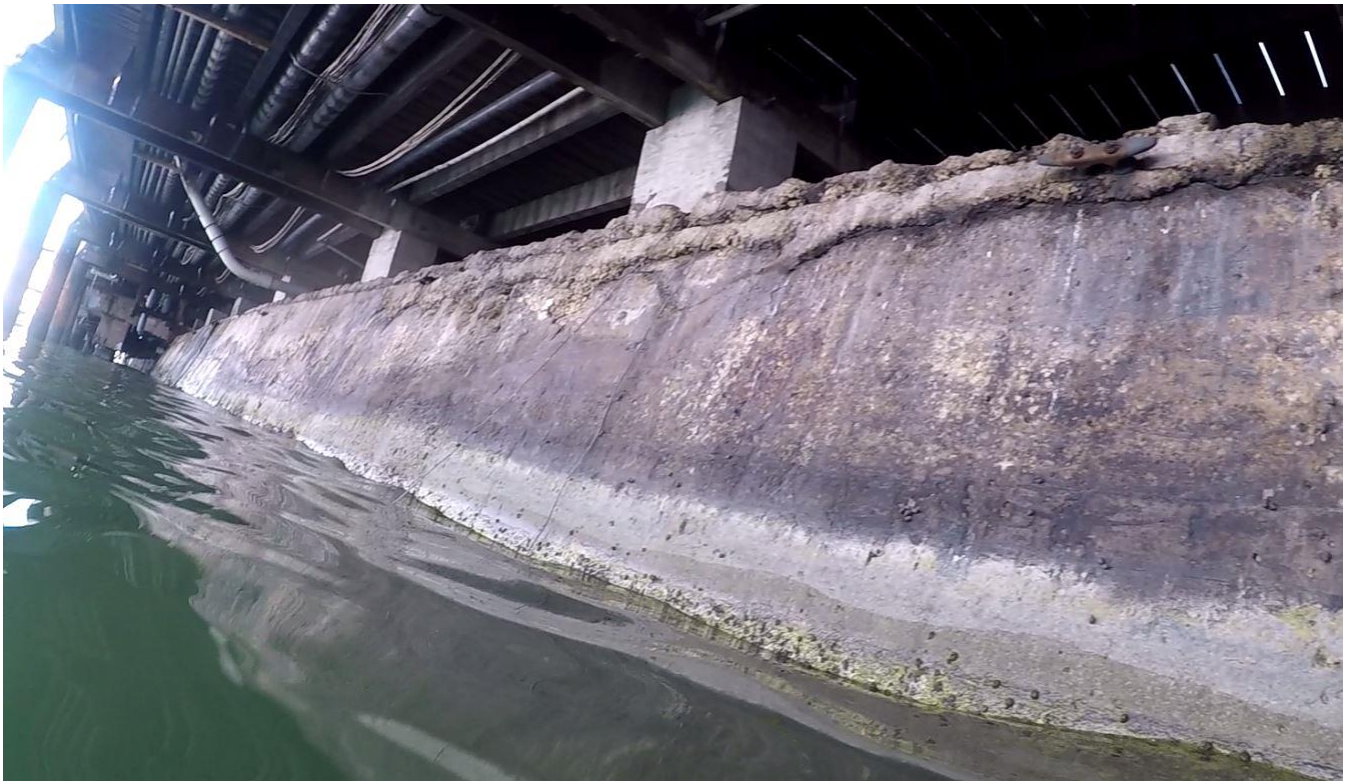
Underwater 13 - at 89ft above waterline looking east shows wall condition and utilities

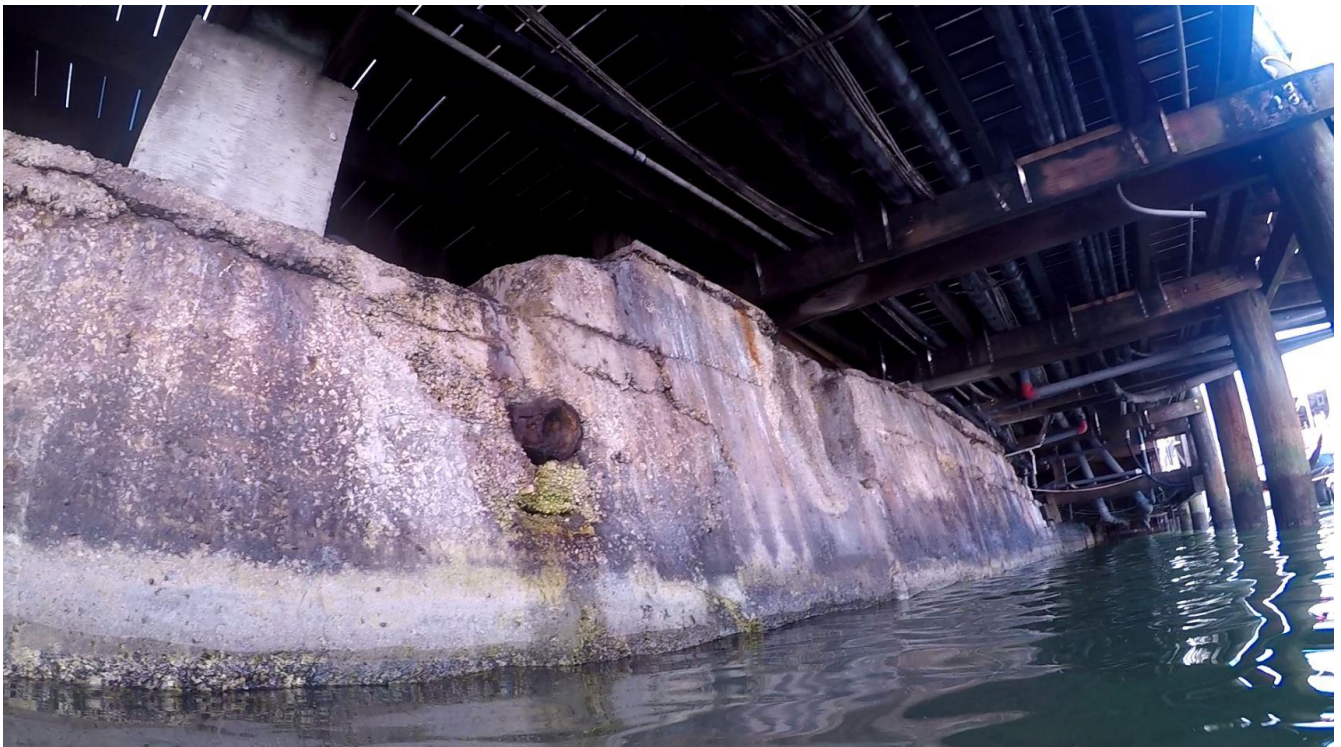
Underwater 14 - at 89ft above waterline looking west shows wall and utilities

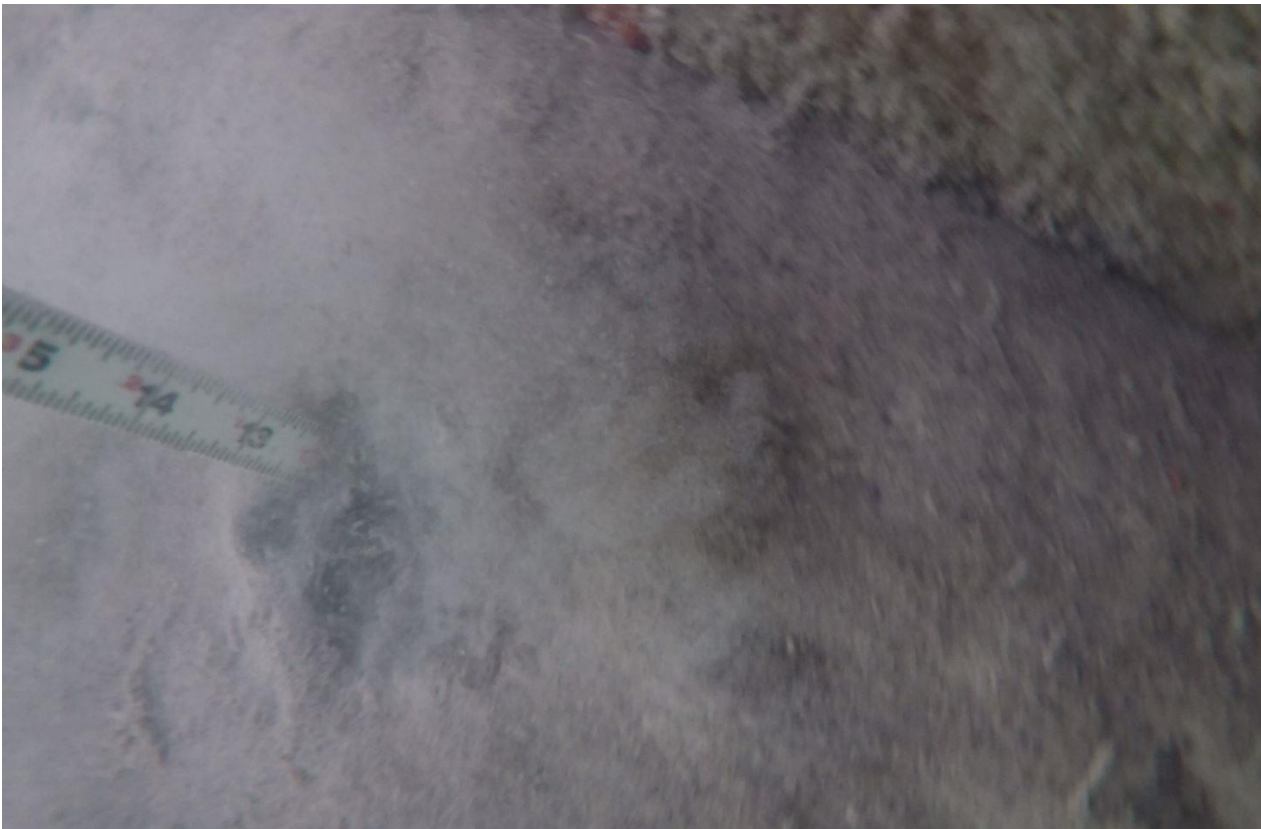
Underwater 15 - at 89ft shows sediment in front of toe wall 12in deep

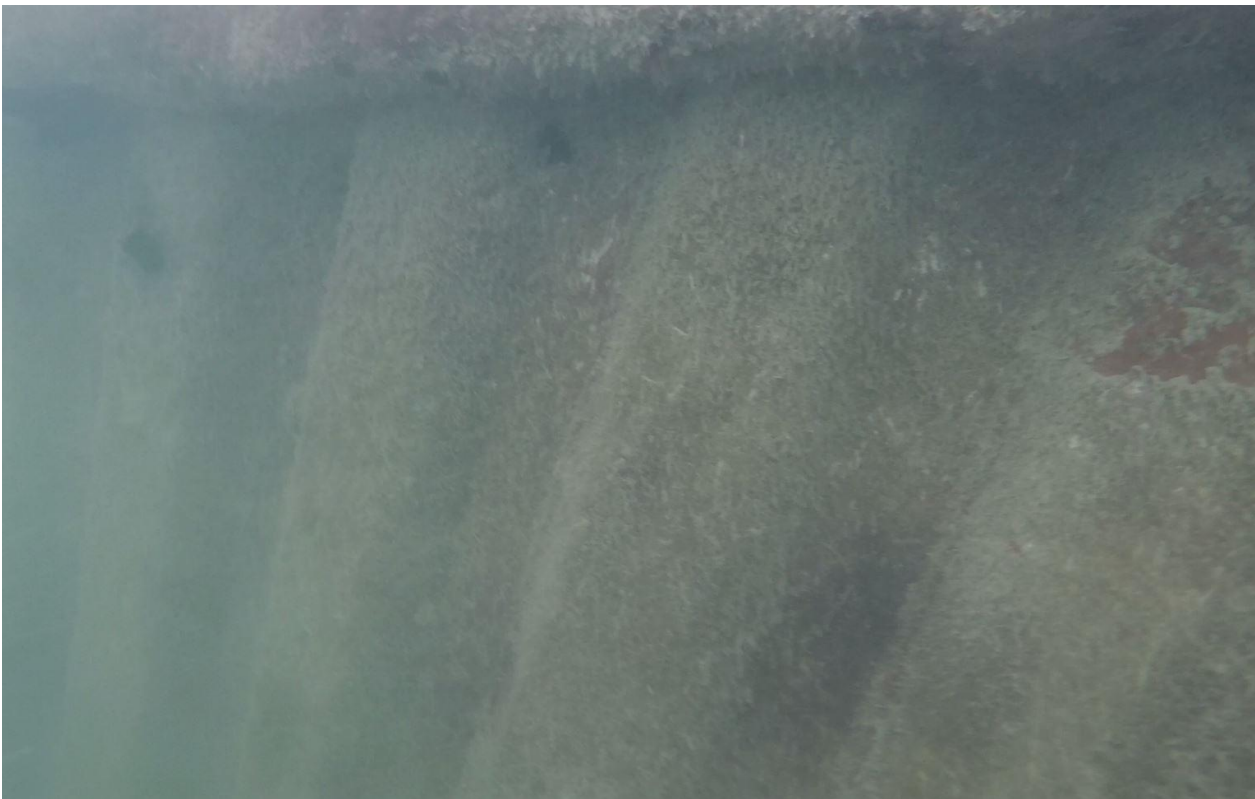
Underwater 16 - at 110ft shows steel sheet toe wall with concrete cap

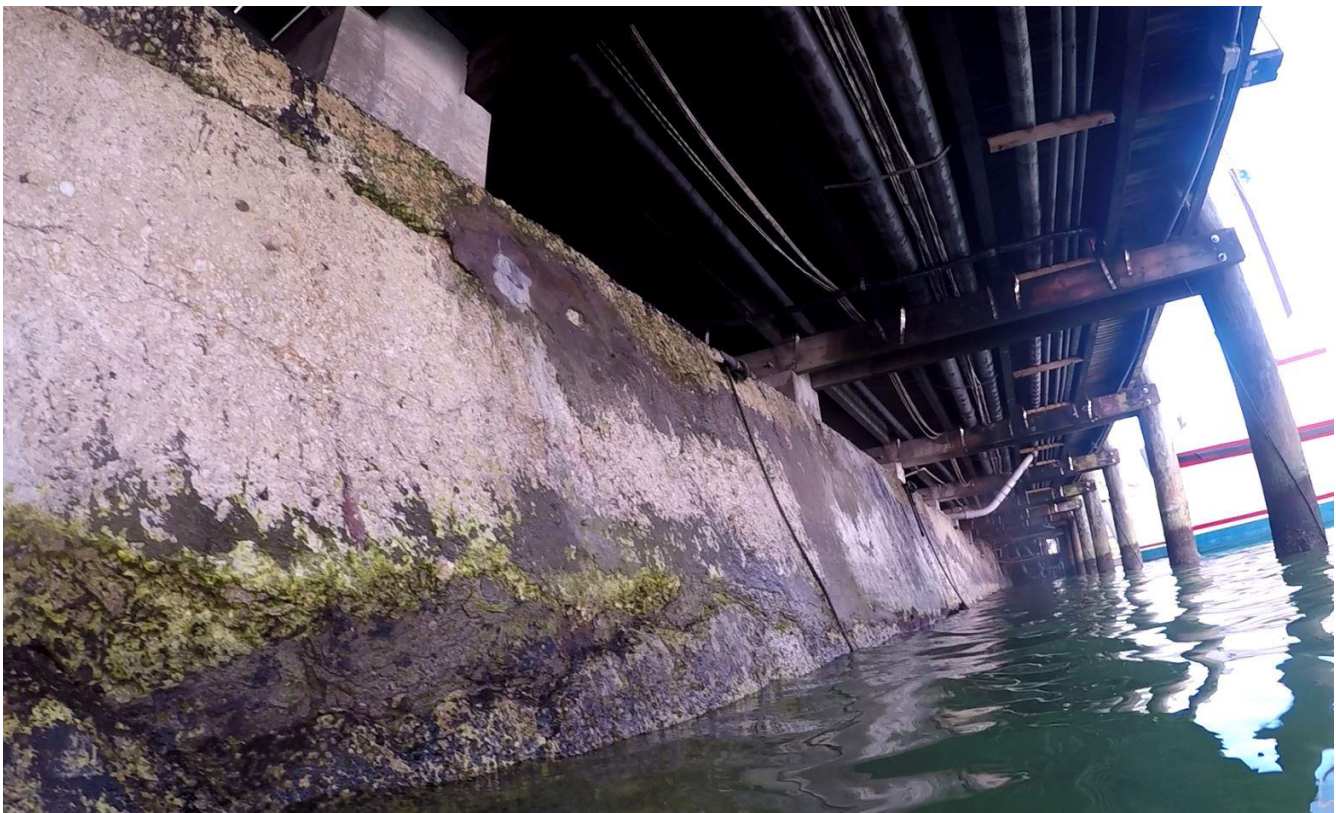
Underwater 18 - at 140ft above waterline looking west shows wall condition and utilities

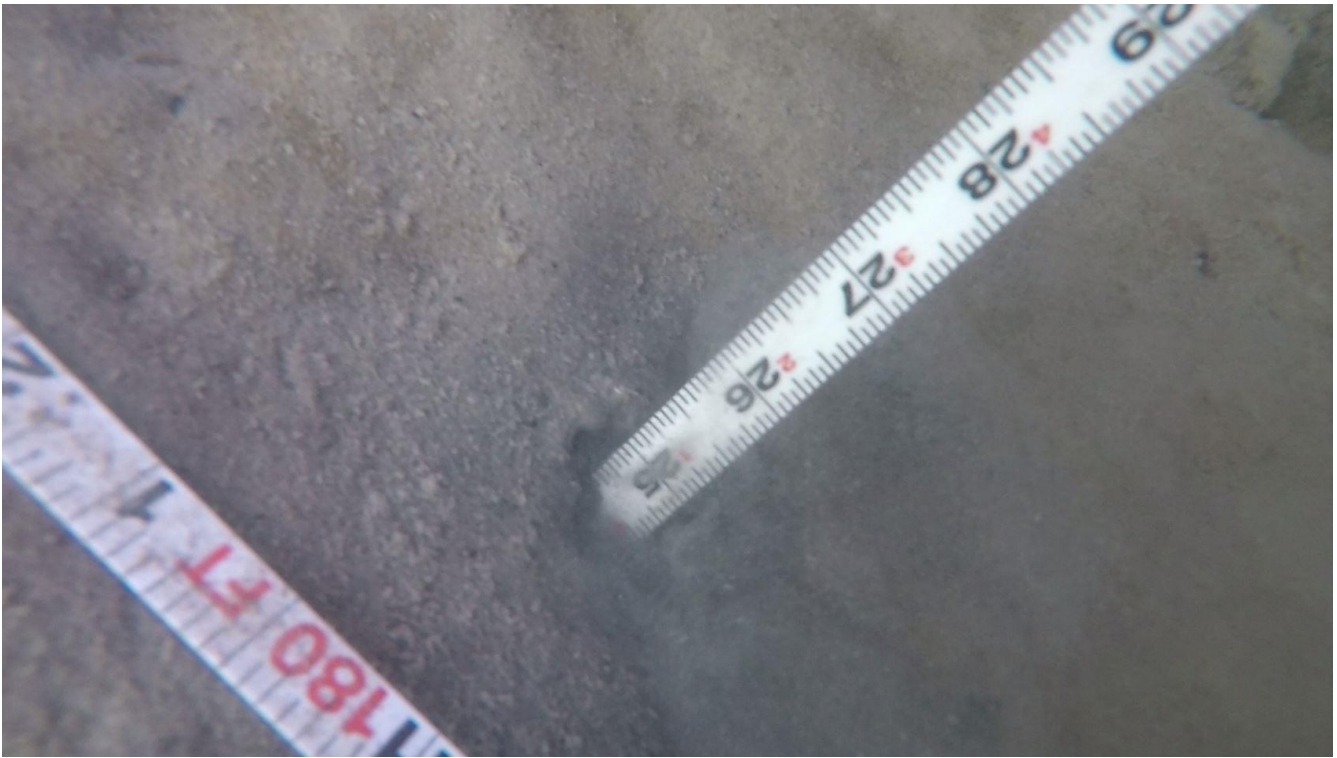
Underwater 21 - at 180ft the soft sediment is 25in deep

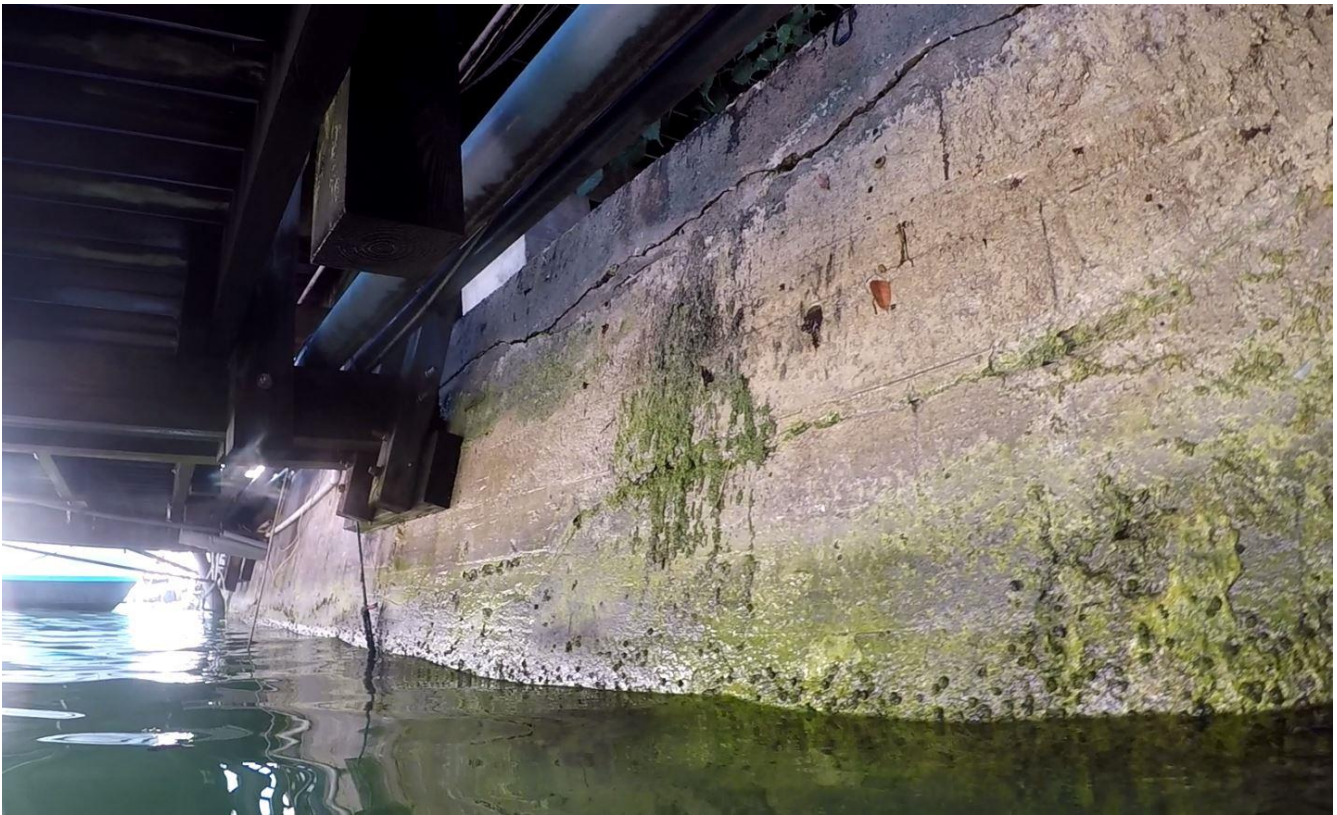
Underwater 22 - at 204ft above waterline looking east

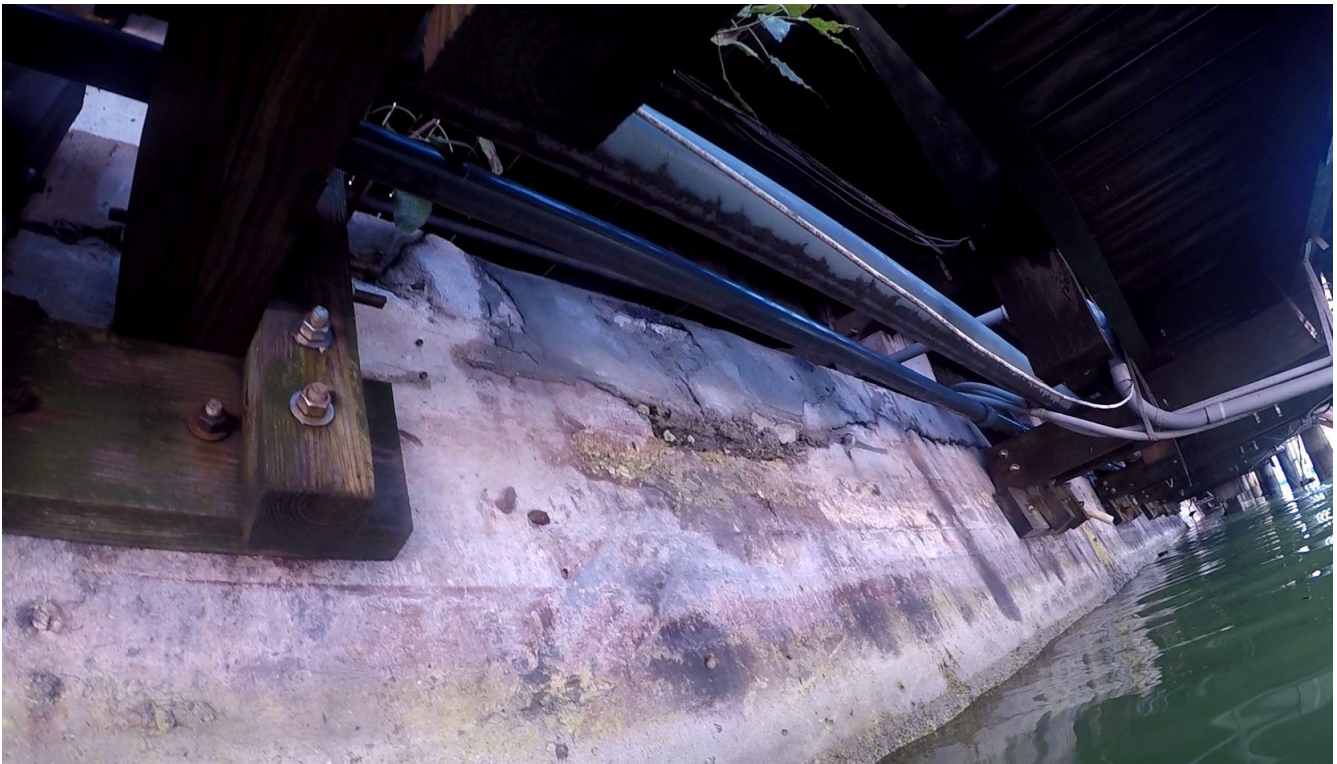
Underwater 23 - at 204ft above waterline looking west

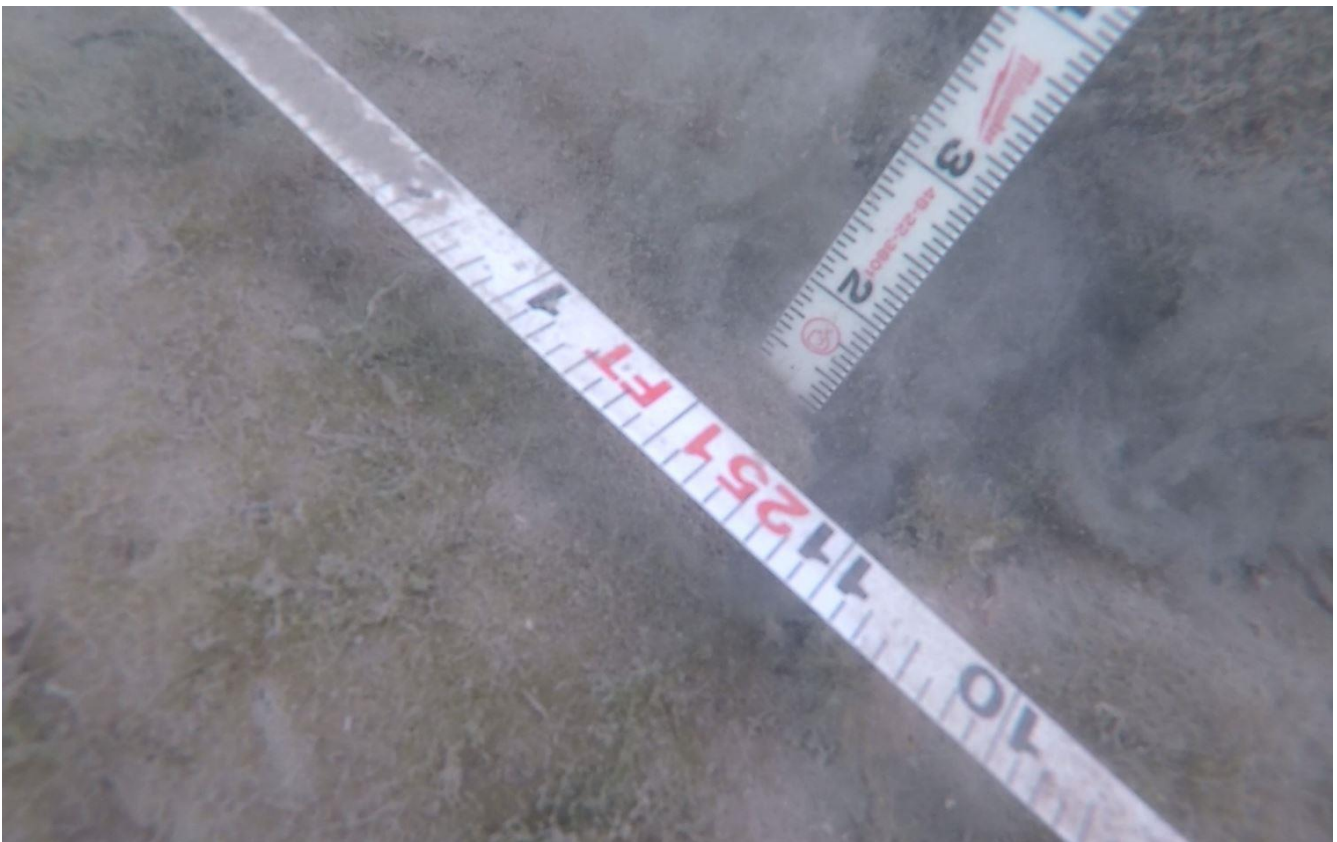
Underwater 26 - at 251ft shows 1in of sediment at toe

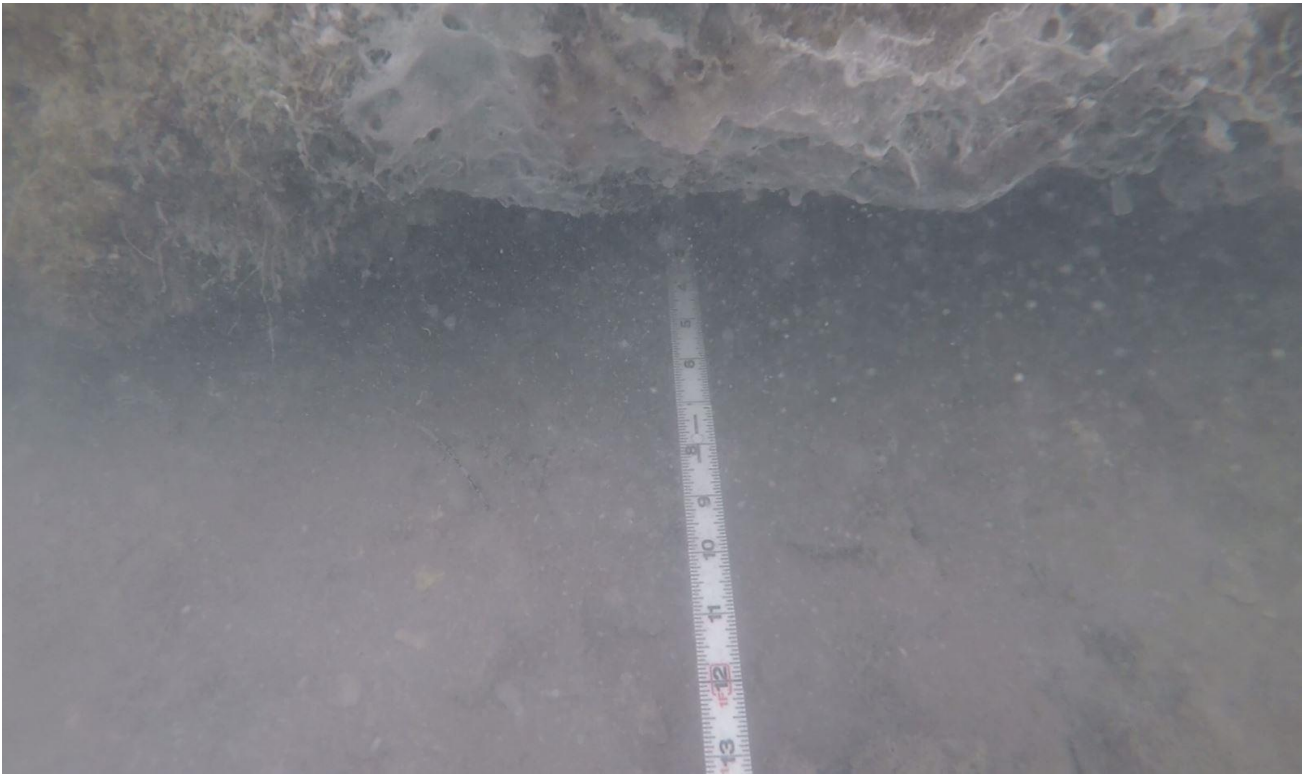
Underwater 27 - at 269ft shows 8in void at toe of wall

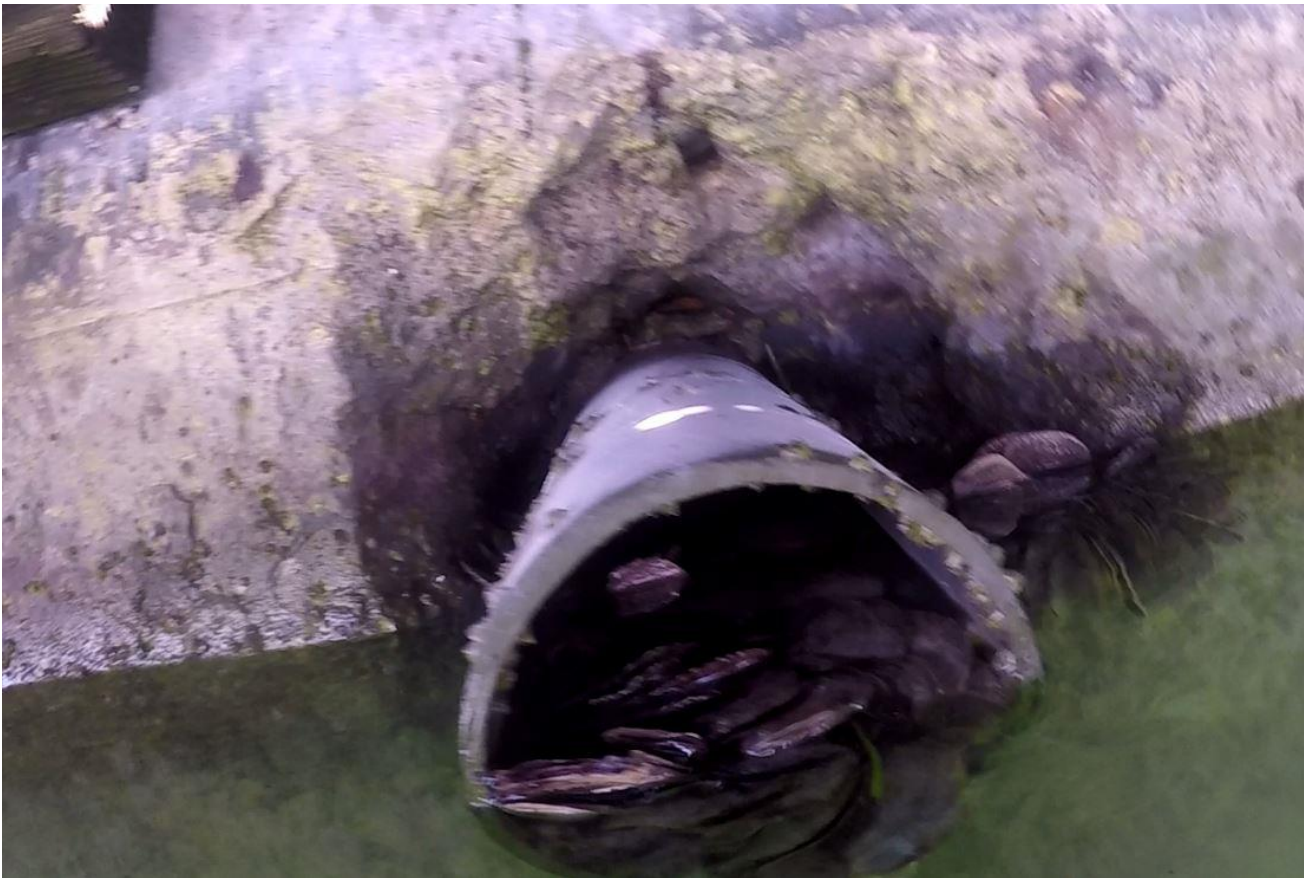
Underwater 28 - at 290ft above water line shows 12in diameter HDPE pile full of barnacles

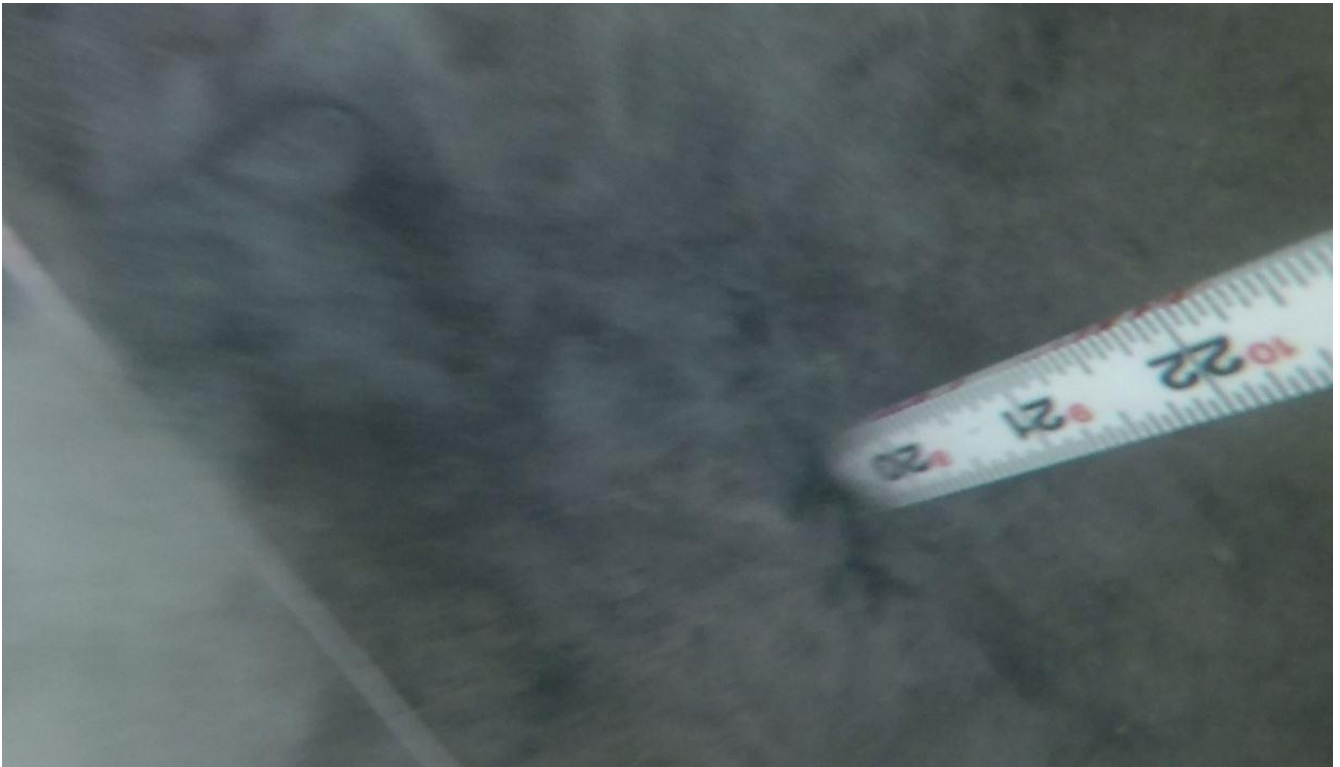
Underwater 30 - at 295ft shows sediment 19in deep

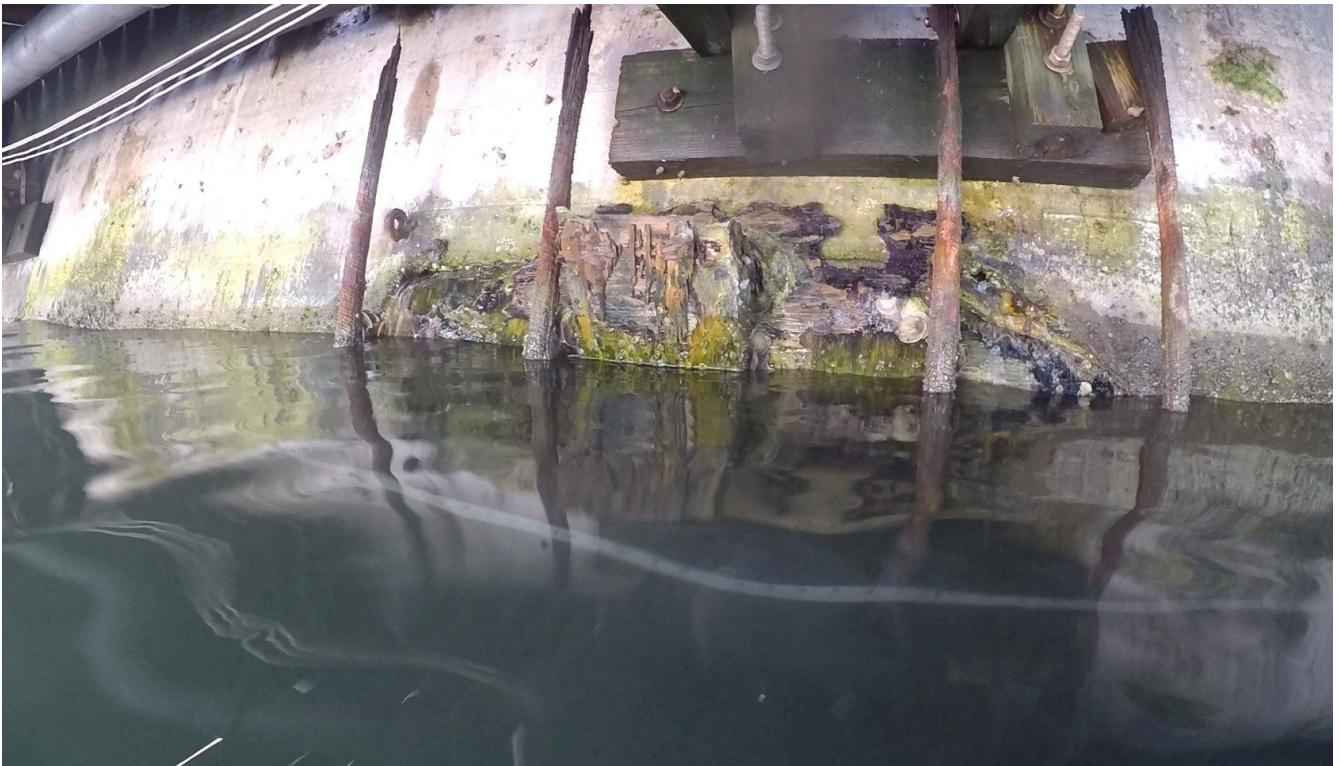
Underwater 33 - at 339ft above water looking at plug

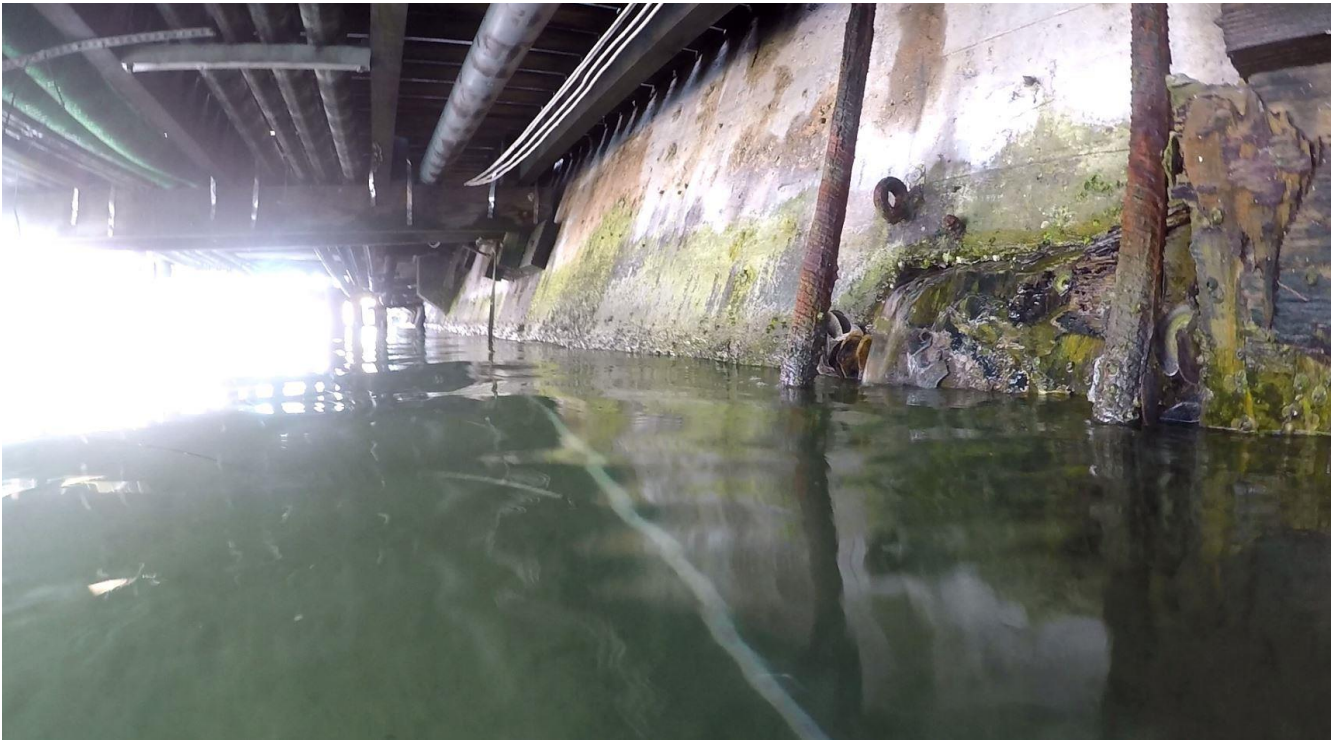
Underwater 34 - at 339ft above water looking east above plug

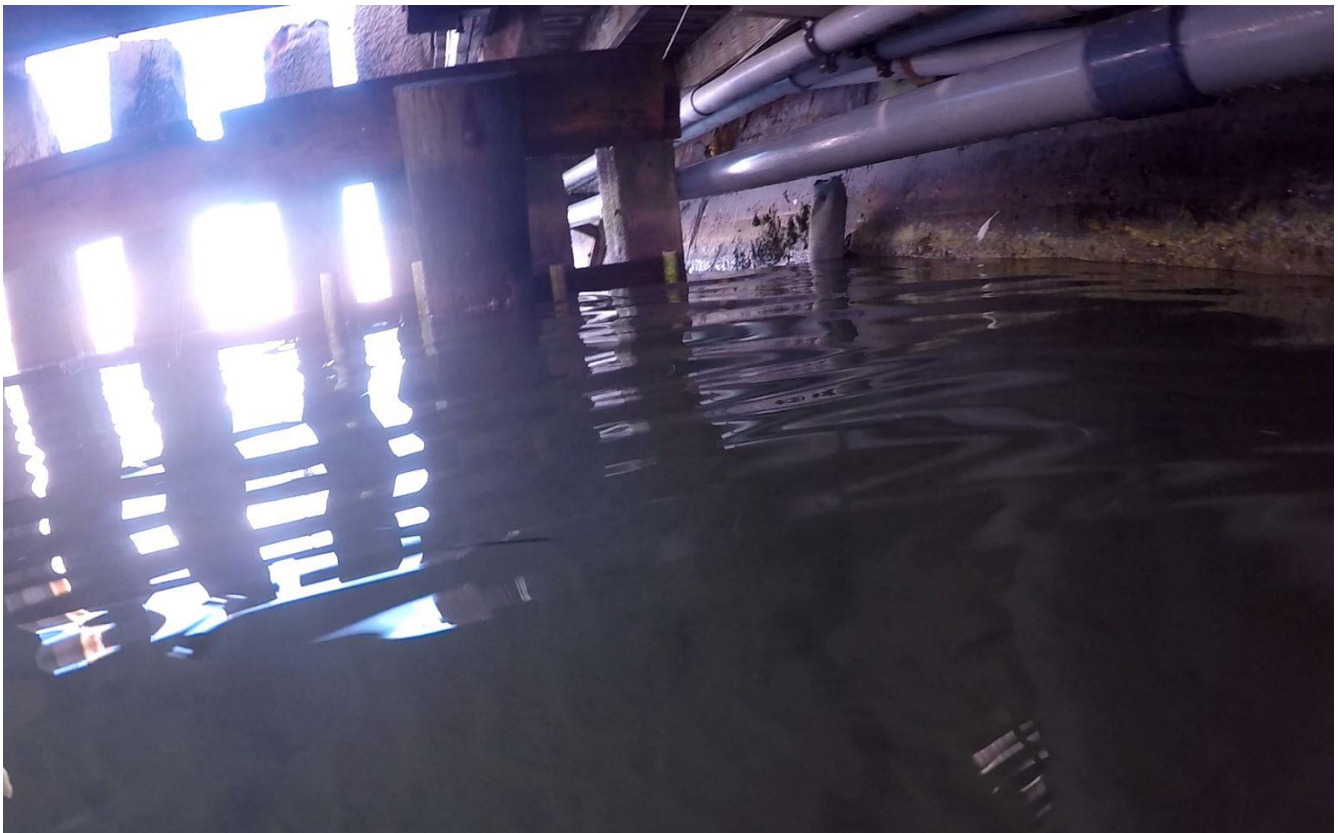
Underwater 36 - at 350ft above waterline looking east at old turtle pen fence

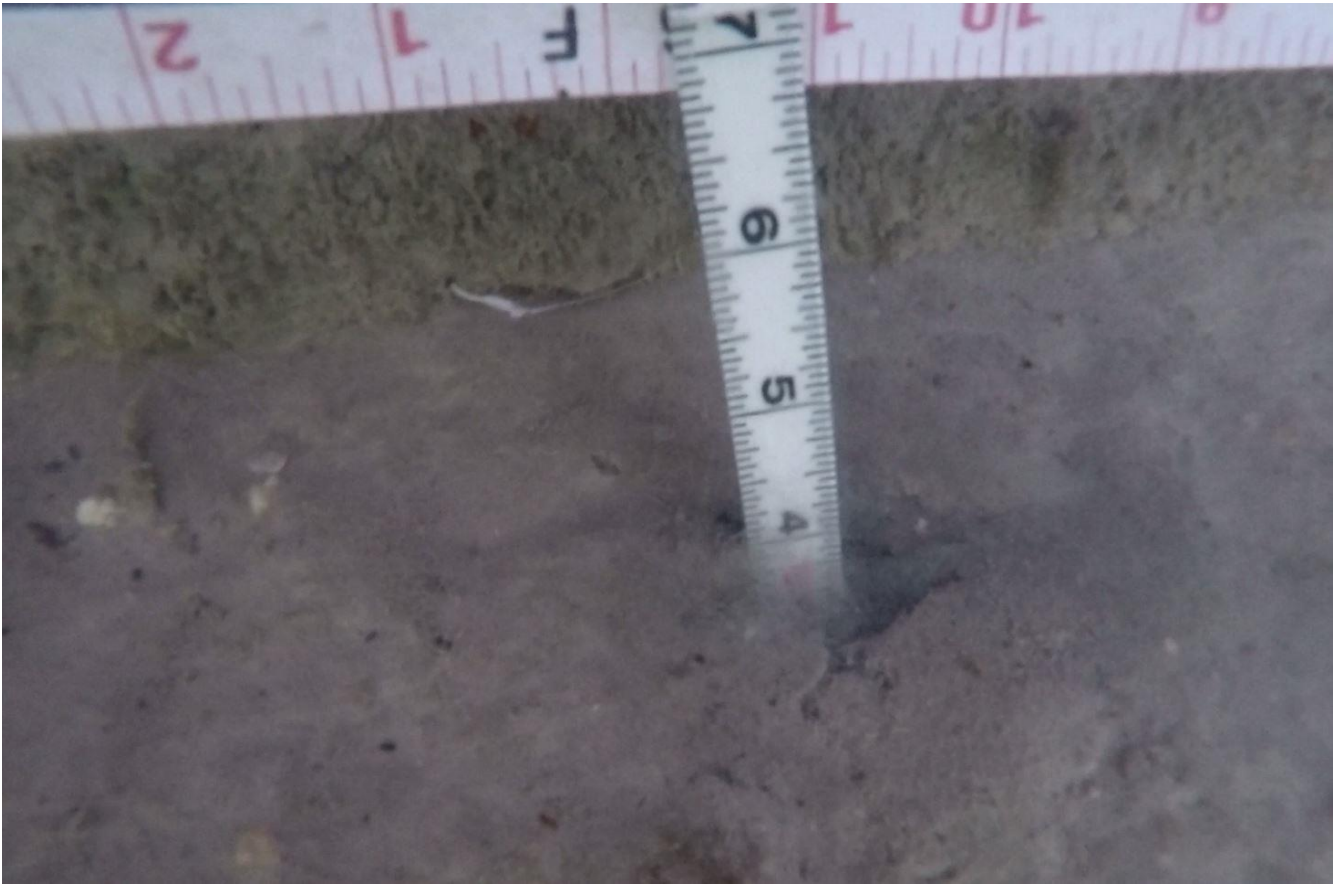
Underwater 37 - at 350ft showing 4in sediment

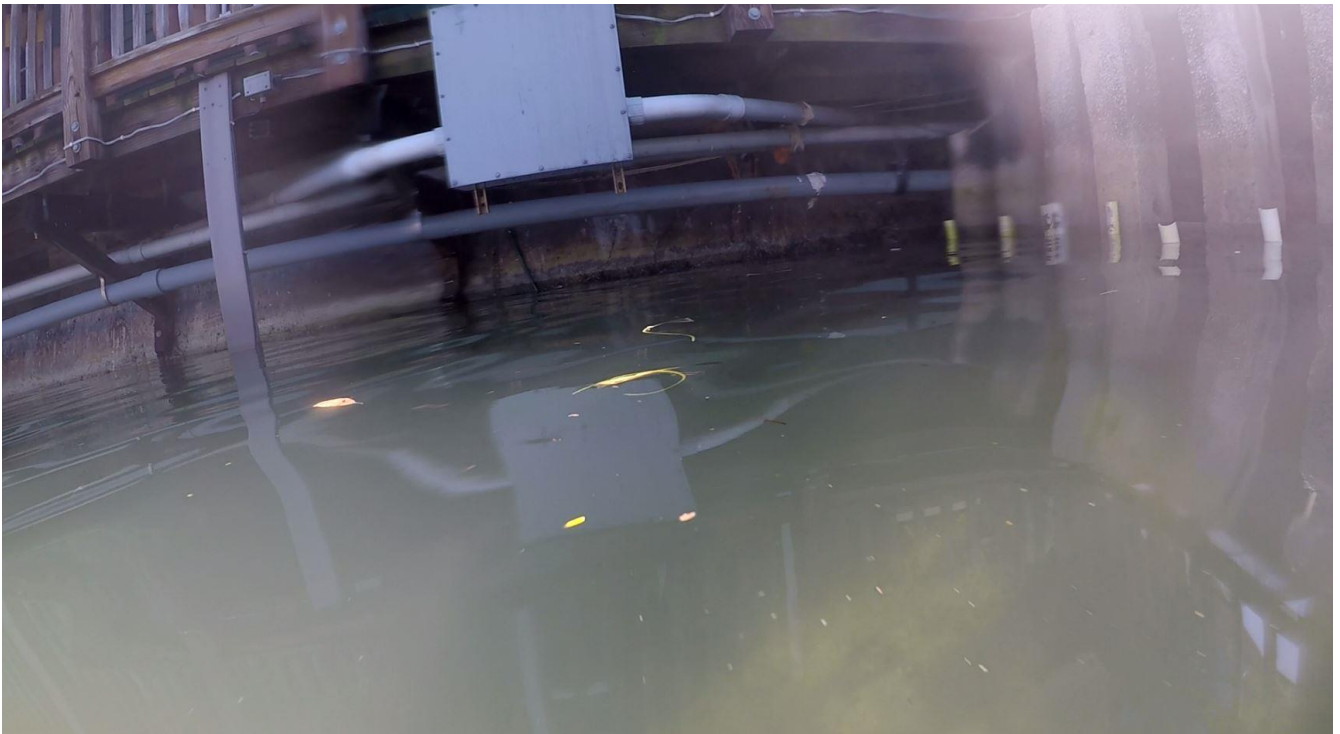
Underwater 38 - at 375ft inside turtle pen above waterline looking at wall showing utilities
