**Subject: Seawall Condition Assessment
From Turtle Kraals to William Street
Resolution No. 17-017**

CITY OF KEY WEST
PORT & MARINE SERVICES

SEAWALL CONDITION ASSESSMENT
WATERFRONT MARKET TO TURTLE KRAALS RESTAURANT

RESOLUTION NO. 17-017

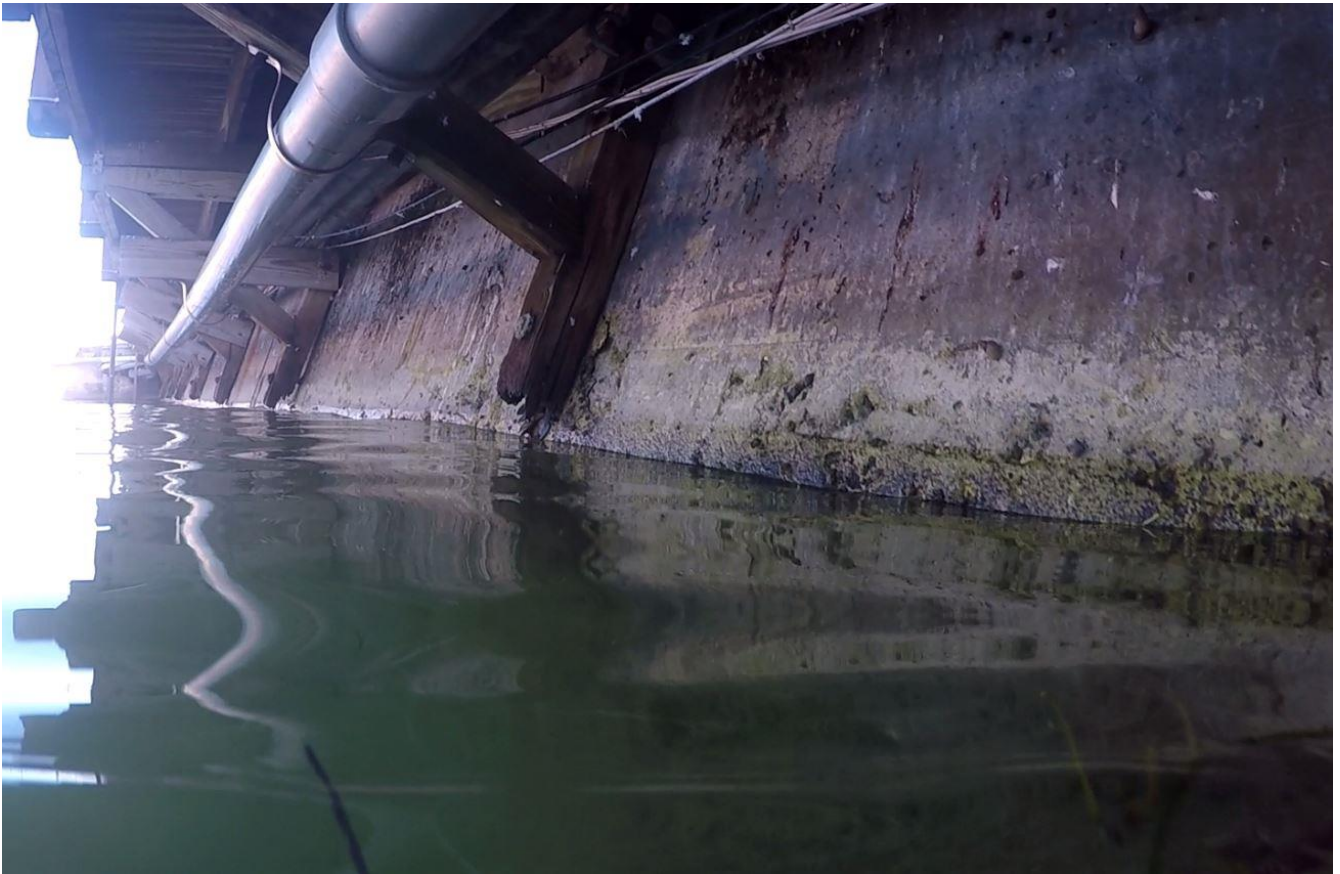
Underwater 39 - at 380ft above waterline looking east

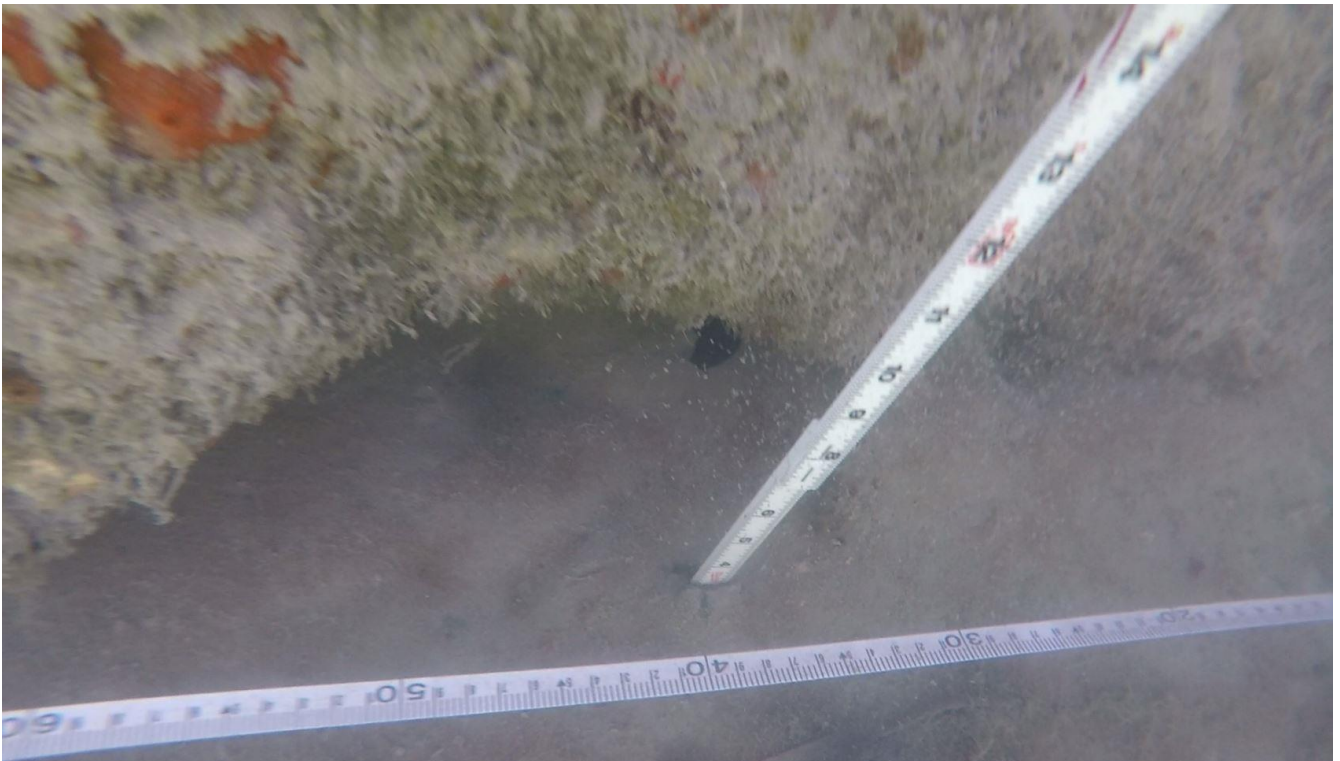
Underwater 40 - at 387ft showing 3in sediment in front of an 8in void

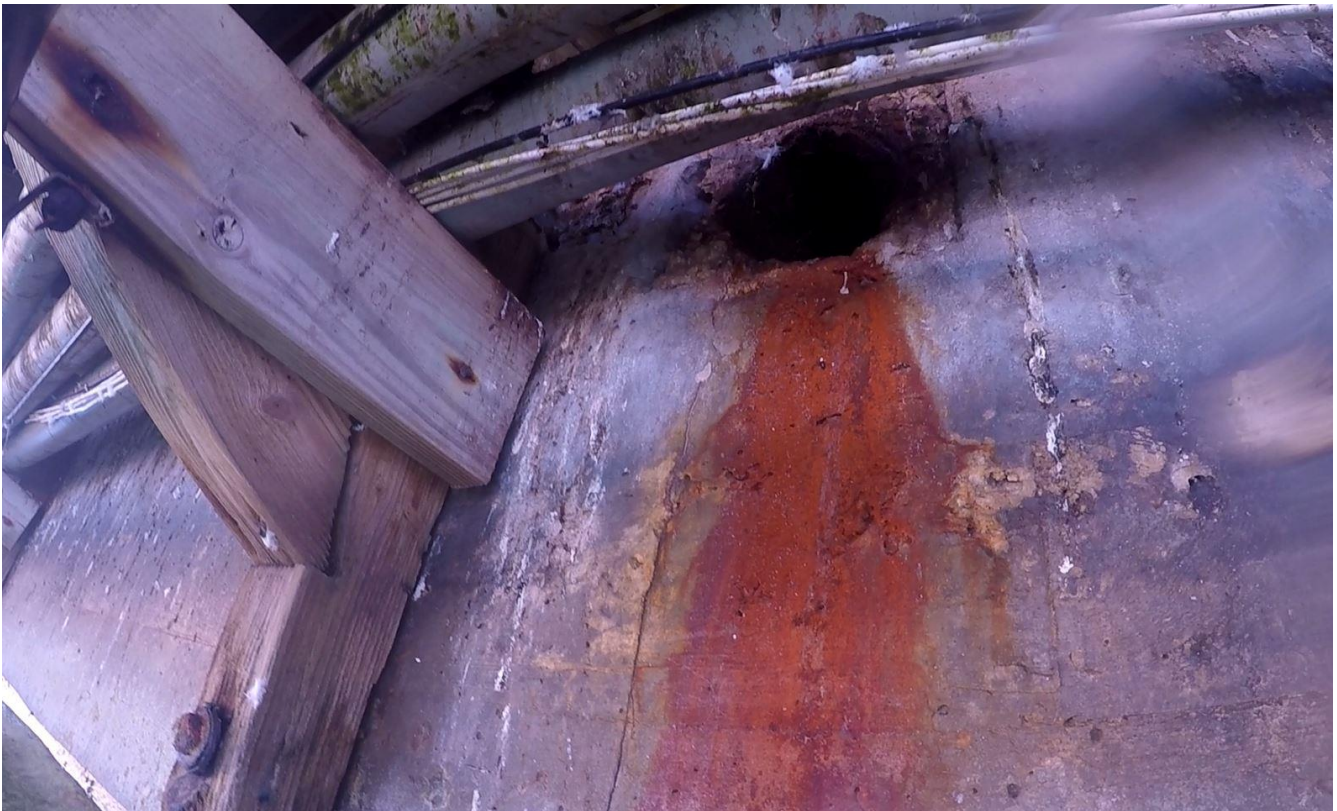
Underwater 41 - at 390ft above waterline showing 8in diameter drain and utilities
