CITY OF KEY WEST  
PORT AND MARINE SERVICES

KEY WEST BIGHT SEAWALL INVESTIGATION  
PHASE III  
SCHOONER WHARF TO CONCH REPUBLIC

SUBMITTED: February 5, 2018  
REVISED: May 10, 2018

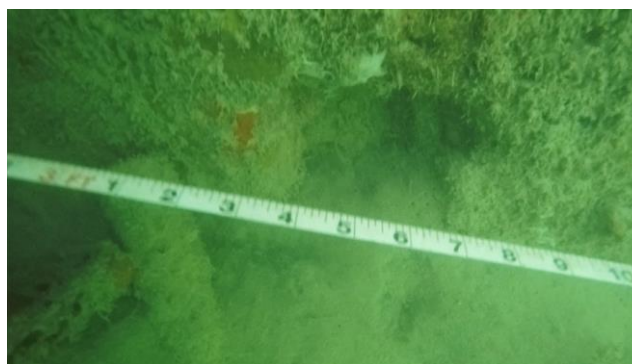
Figure 4: A-A, STA 0+03, 8" Hole (View 1)

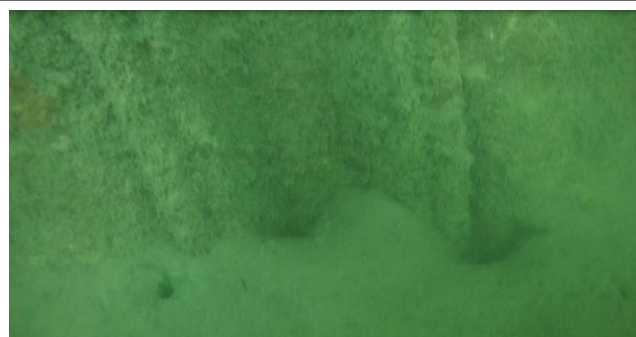
Figure 6: A-A, STA 0+35, Typical Sheet Embedment

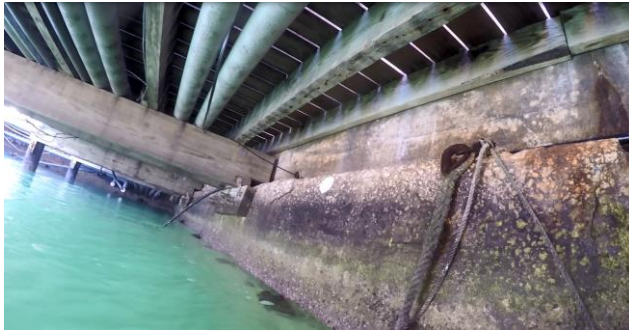
Figure 8: B-B, STA 0+00, Representative example of pitting

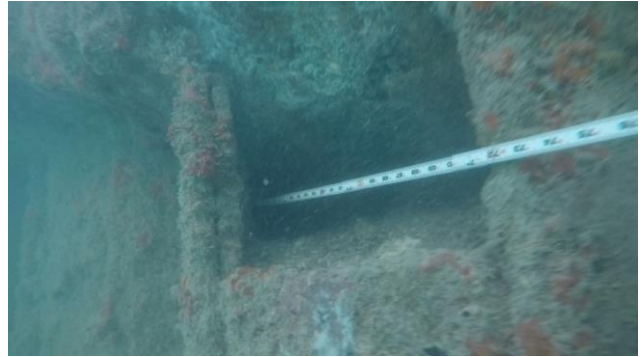
Figure 9: B-B, STA 0+35, 14"x14"x39" Void

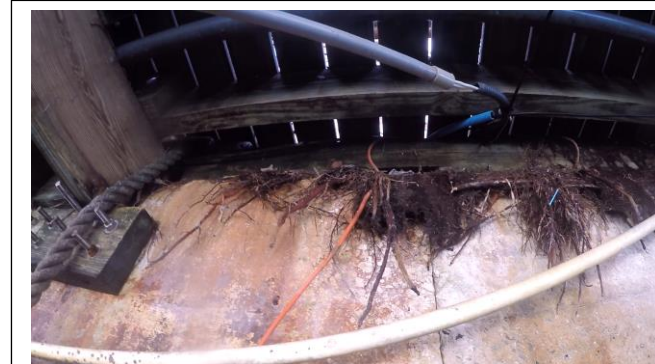
Figure 16: B-B, STA 1+22, Roots overhang wall

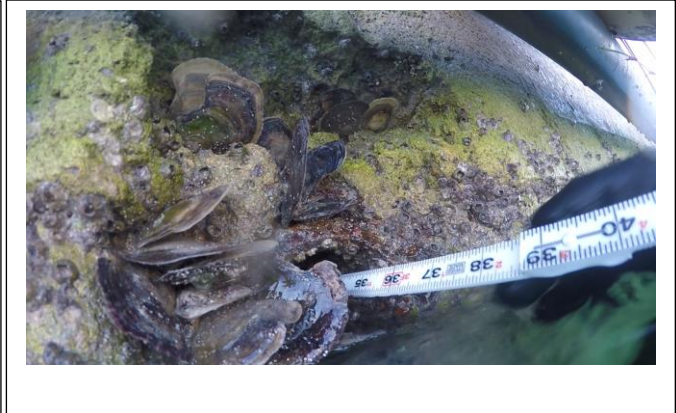
Figure 19: B-B, STA 1+71, 36" deep void in cap

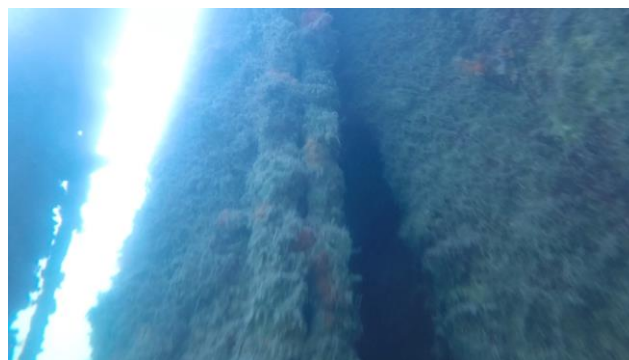
Figure 27: C-C, STA 1+36, (View 2)

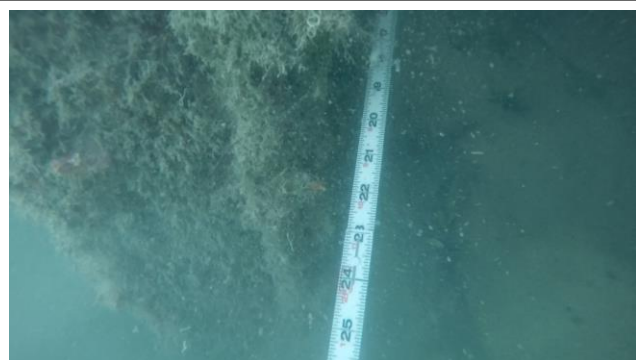
Figure 28: C-C, STA 1+36, Void space of 20"

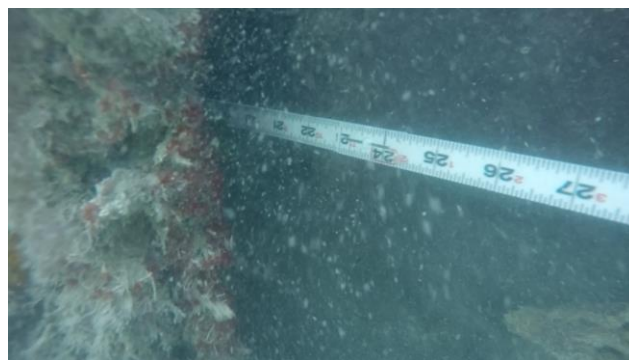
Figure 31: C-C, STA 1+69, (View 2)

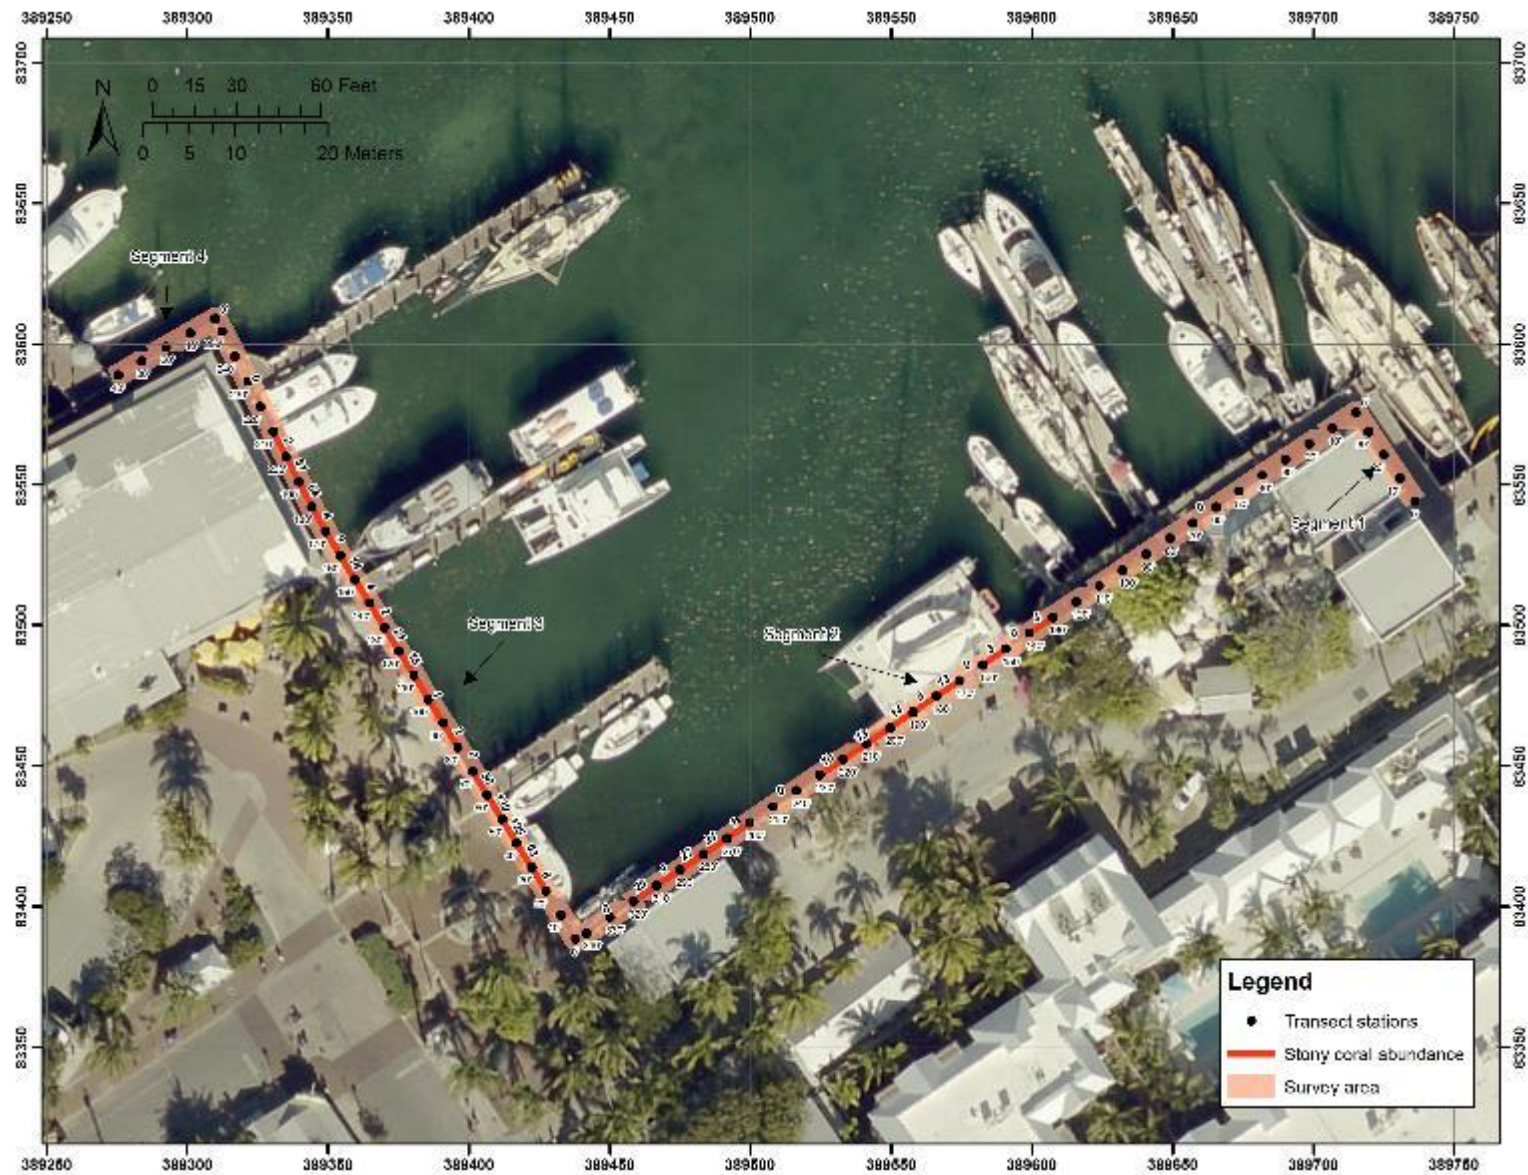
Figure 3. Coral abundance by tape segment (10-ft.)

The highest abundance of stony corals (264 colonies) are along the third segment of tape from 140-160 ft. These corals are encrusted to hardbottom (37 colonies) and rubble (227 colonies) 2-5 ft. from the bulkhead. The second highest abundance of coral colonies (145) are along the third segment of tape from 180-200 ft. Of these, the corals between the 180-195 ft. marks are attached to the bulkhead and cannot be relocated, regardless of size, due to their morphology (encrusting corals). Colonies between the 197-199 ft. marks are on movable rubble 2-4 ft. from the bulkhead and able to be relocated (23 colonies total). Figure 3 presents the coral inventory by transect segment in 10-ft. increments.

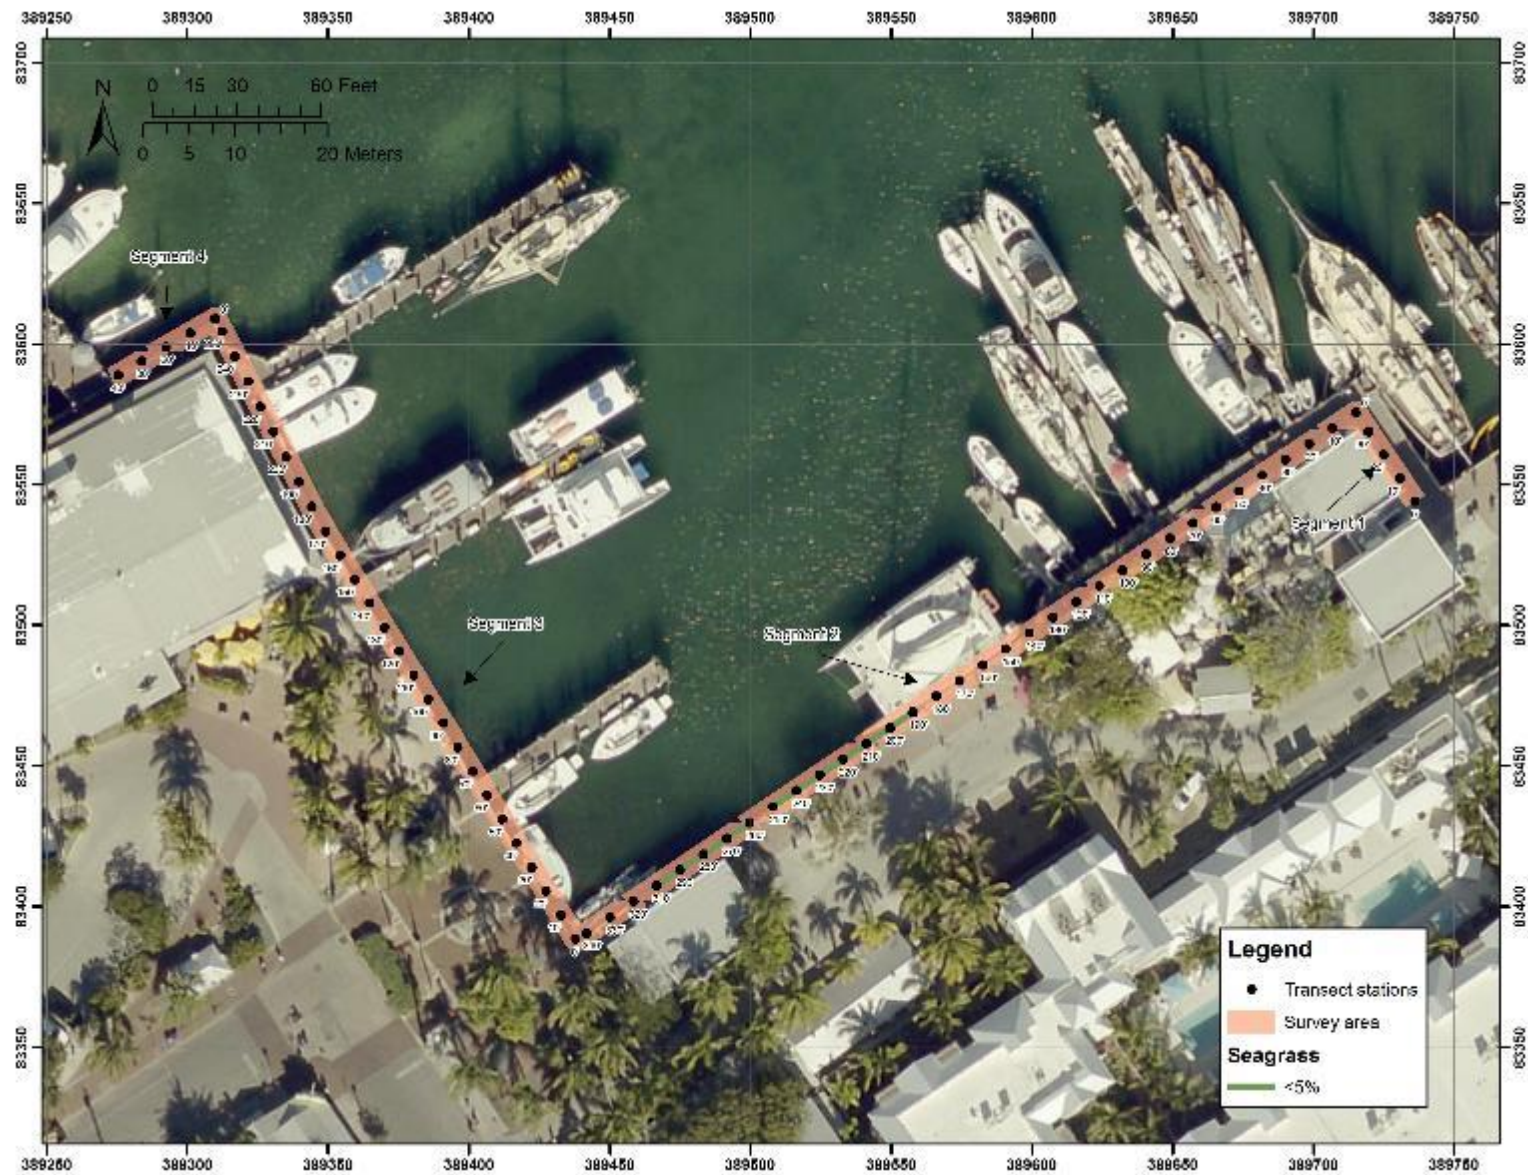
Figure 8. Seagrass cover by tape segment (10-ft)

Discontinuous seagrass (*Halophila decipiens*) cover was documented from 196-246 ft. and 265-300 ft. along the second segment of bulkhead. Seagrasses were encountered growing within the 5-10 ft. buffer zone adjacent to the base of the bulkhead with coverage less than 5%. Table 4 summarizes the abundance and location of seagrass. Figure 8 presents the locations of seagrass cover graphically.

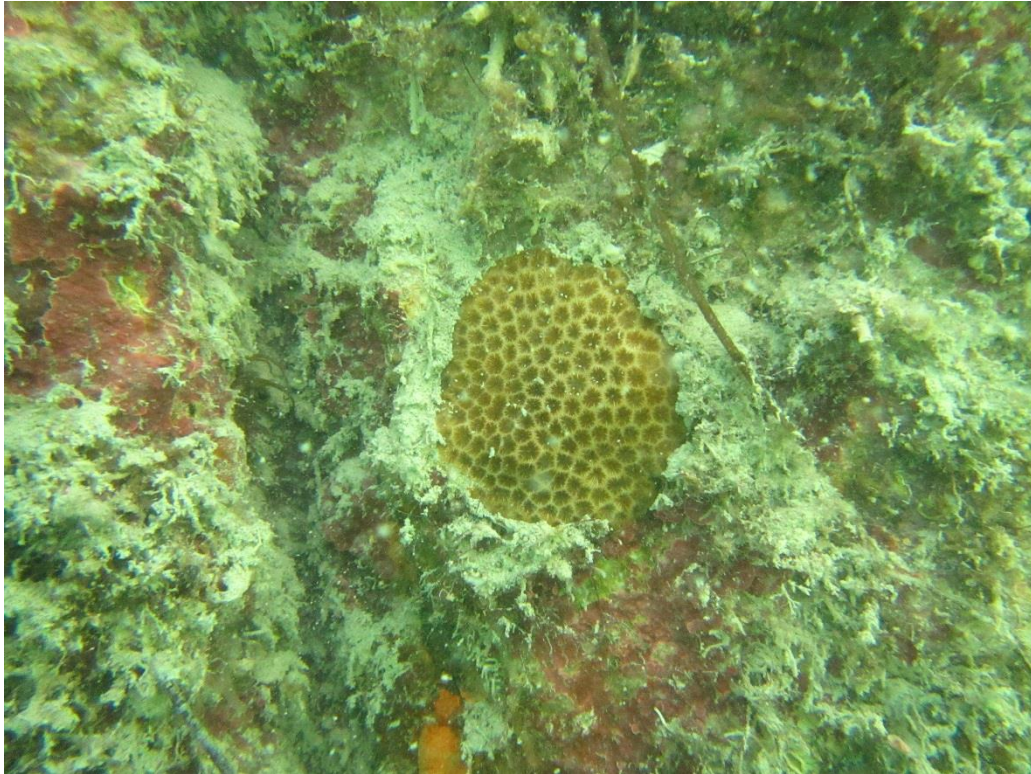
***Siderastrea radians* (Lesser starlet coral)**

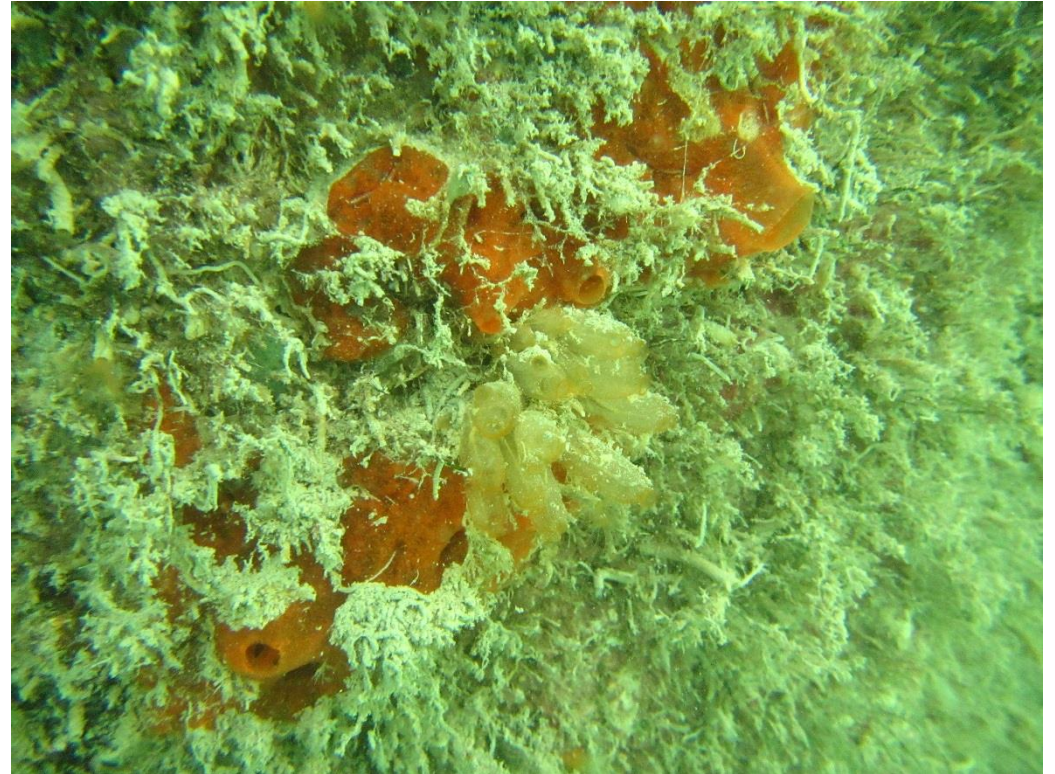
***Ecteinascidia turbinate/Scopalina rutzleri* (Mangrove tunicate/Orange lumpy encrusting sponge)**

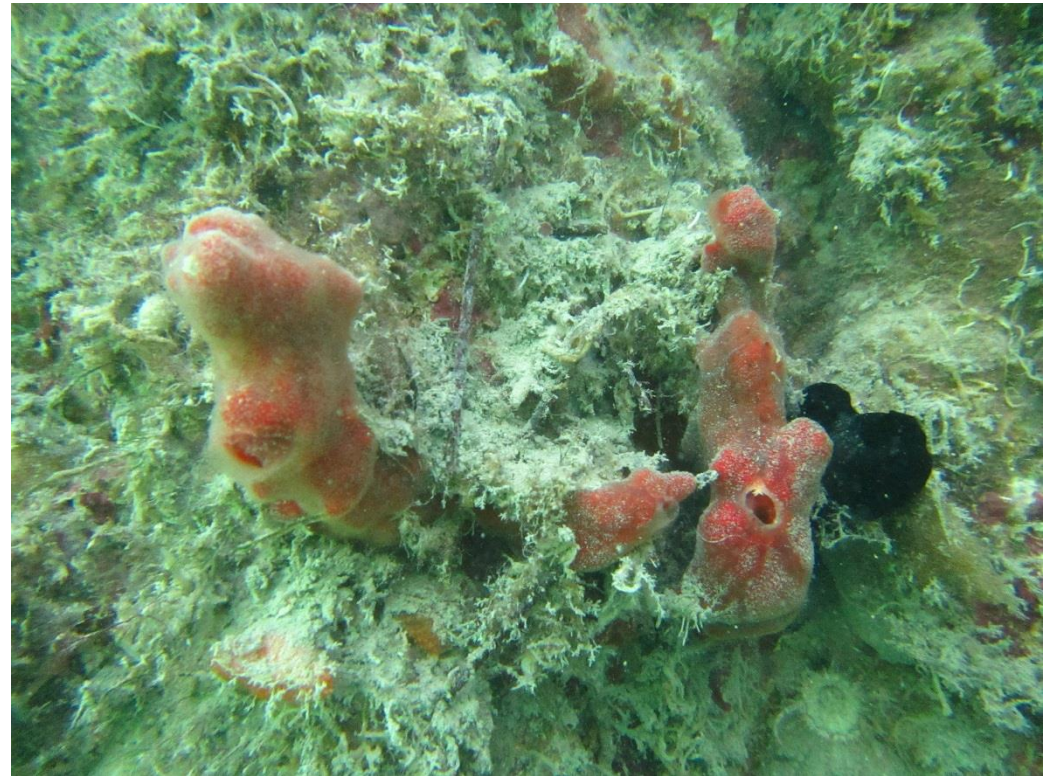
**Other sponges/tunicates**

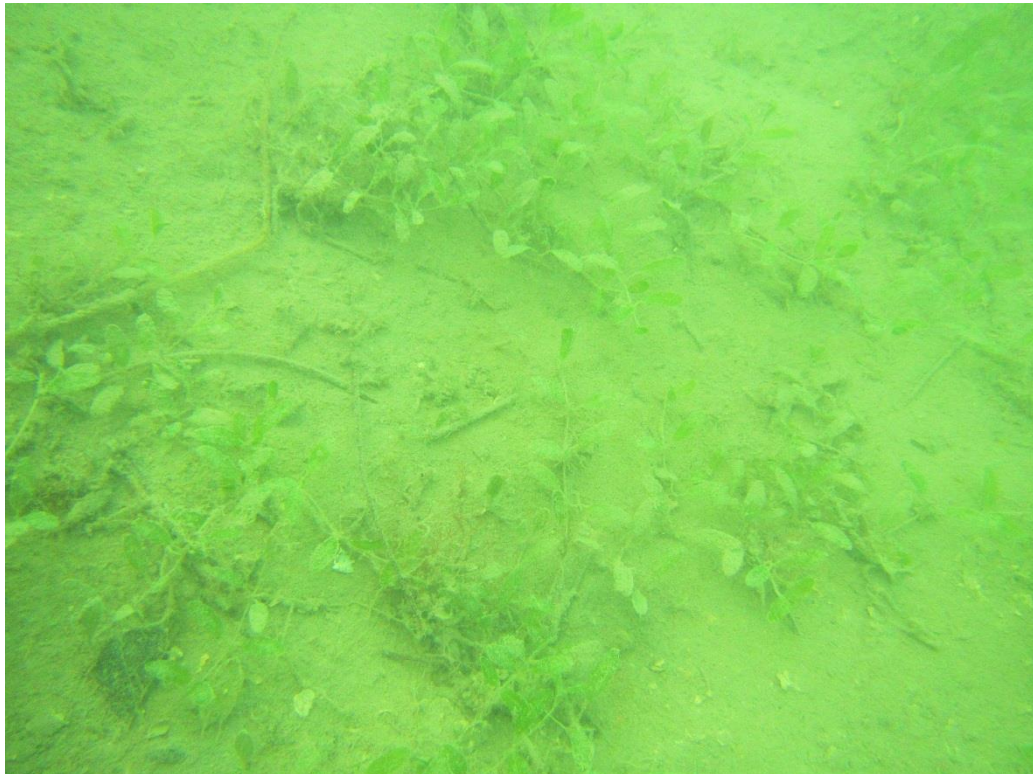
***Halophila decipiens* (Paddle grass)**

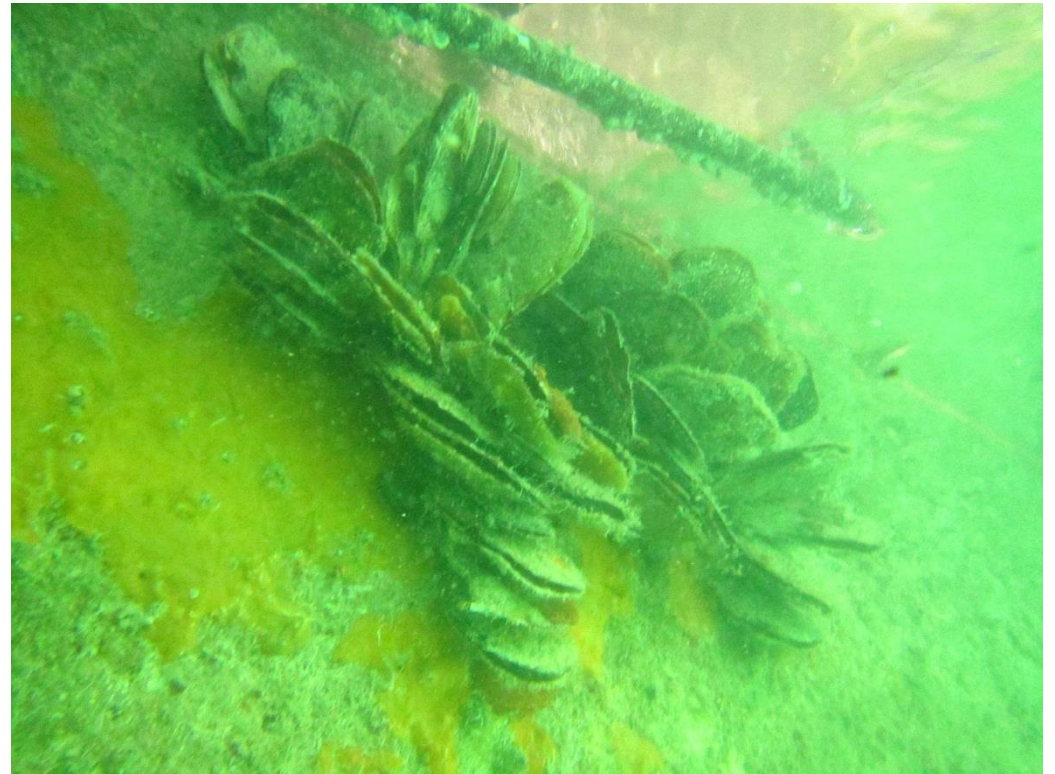
**Bivalves**
